## FIELD REPORT --PEBBLE COPPER/GOLD PROJECT--

**Date:** 5 April 2007

**Objectives:** Site visit to Pebble Project.

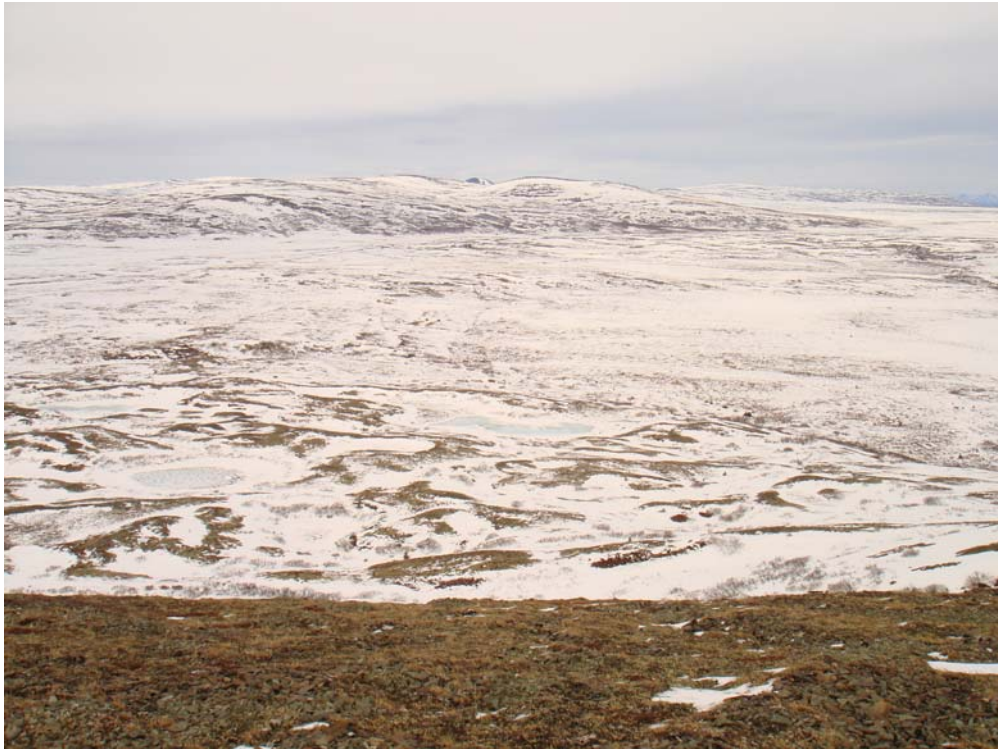
**Figure 1.** View from Koktuli Ridge looking west over project area.

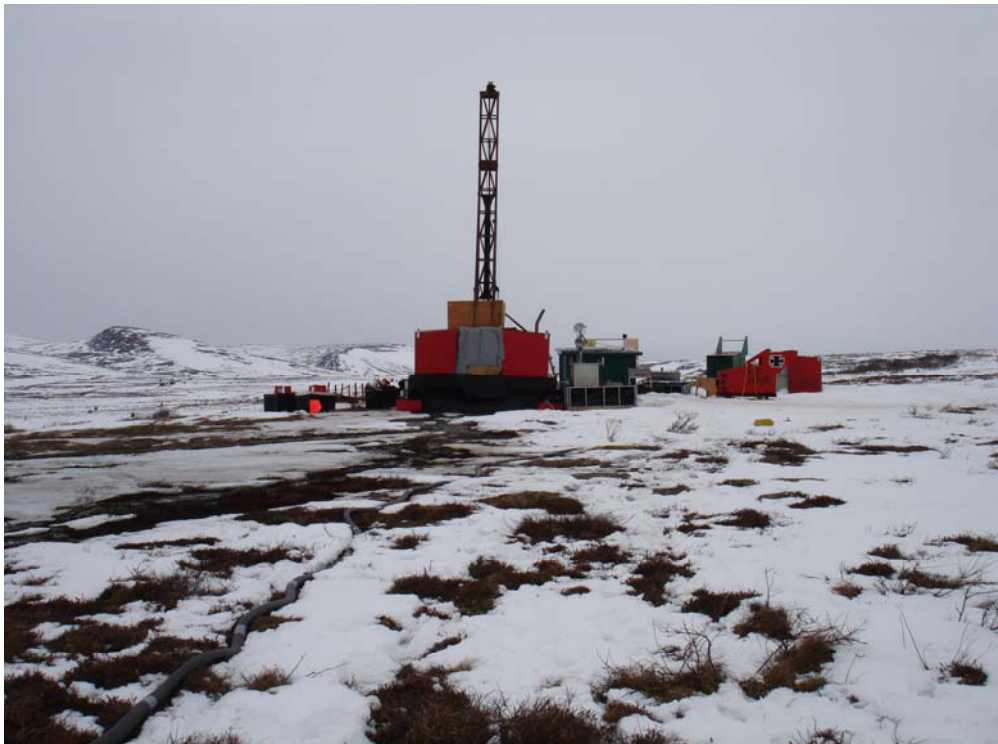
**Figure 2.** Drill rig with supplies and emergency shelter.

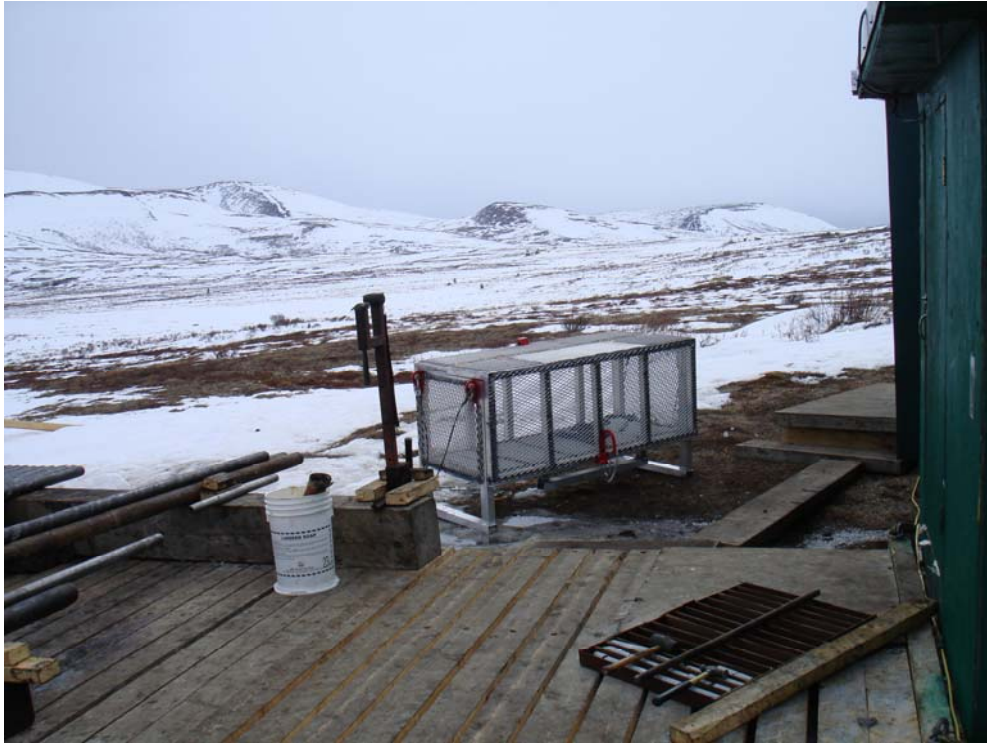
**Figure 3.** Tundra pad and drilling core transport container.

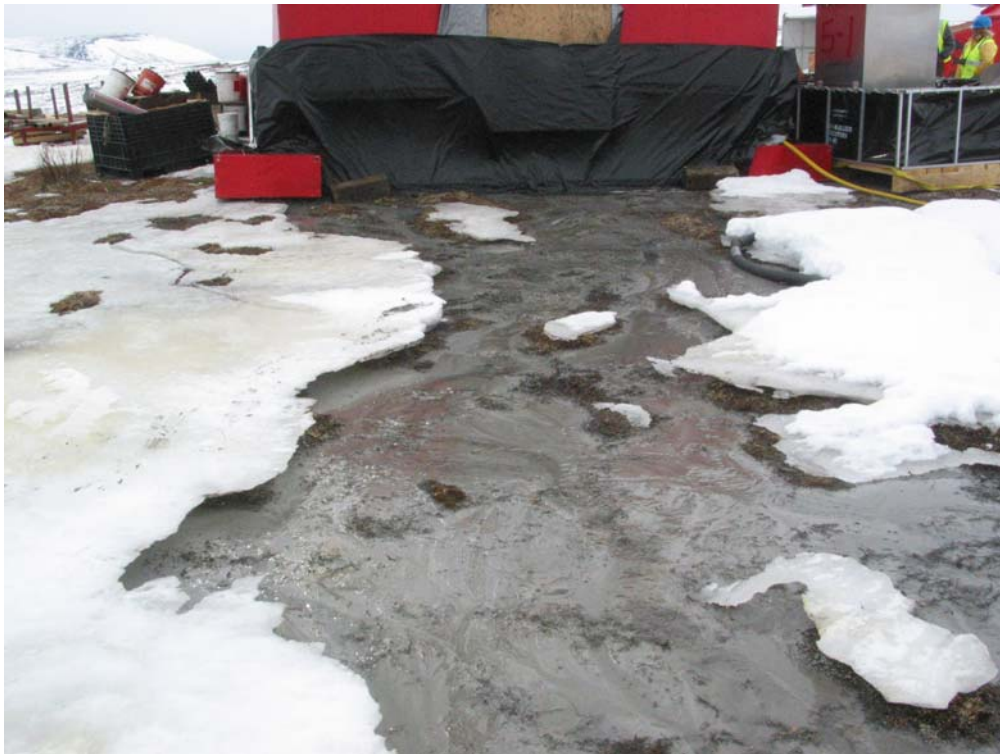
Water and sediment from the drill cuttings was discharged as permitted onto the uplands directly from the drill rigs. A thin layer of sediment and water (less than half an inch thick) was observed within 100 feet downslope of the drill rig. During ice free months a sump pit will be dug to retain drill cuttings. Three reclamation crews will be on site during the summer.

**Figure 4.** Water and cuttings discharge on uplands.

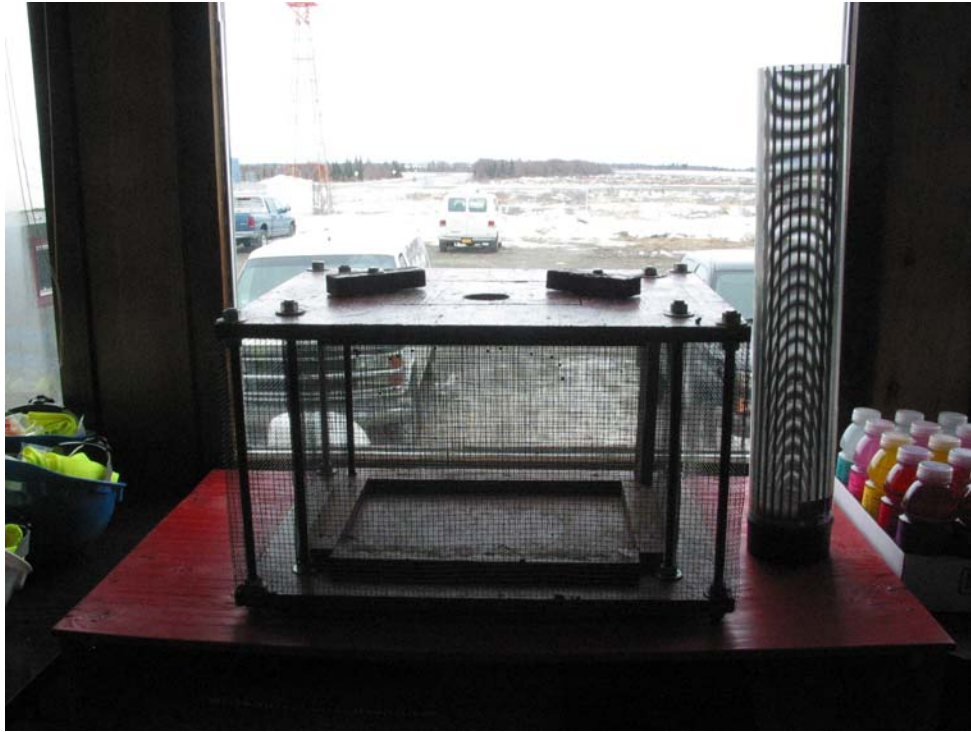
From the drill pad we hiked 1500 feet north along a 2 inch diameter water line to the pump setup at the Upper Talarik. The creek was iced over and water was continuously withdrawn at 20 gallons per minute or less. The surge tank, pump, generator and fuel (in double walled tank) were located in excess of 150 feet from the Upper Talarik itself. The screen box was not visible at this site because of the ice cover, but one was seen for demonstration purposes at the office in Iliamna. These boxes are used at the pump inlet in the waterbody in order to prevent impingement of fish at the orifice. Two of the water withdrawal locations were from the Upper Talarik Creek and the remaining three were in individual non-fish bearing ponds with 3-4 feet of ice.

**Figure 5.** Water withdrawal fish screen box.
