## FIELD REPORT --PEBBLE COPPER/GOLD PROJECT--

**Date:** 22 August 2007

**Objectives:** Site visit to Pebble Project, inspect temporary water use for exploratory drilling.

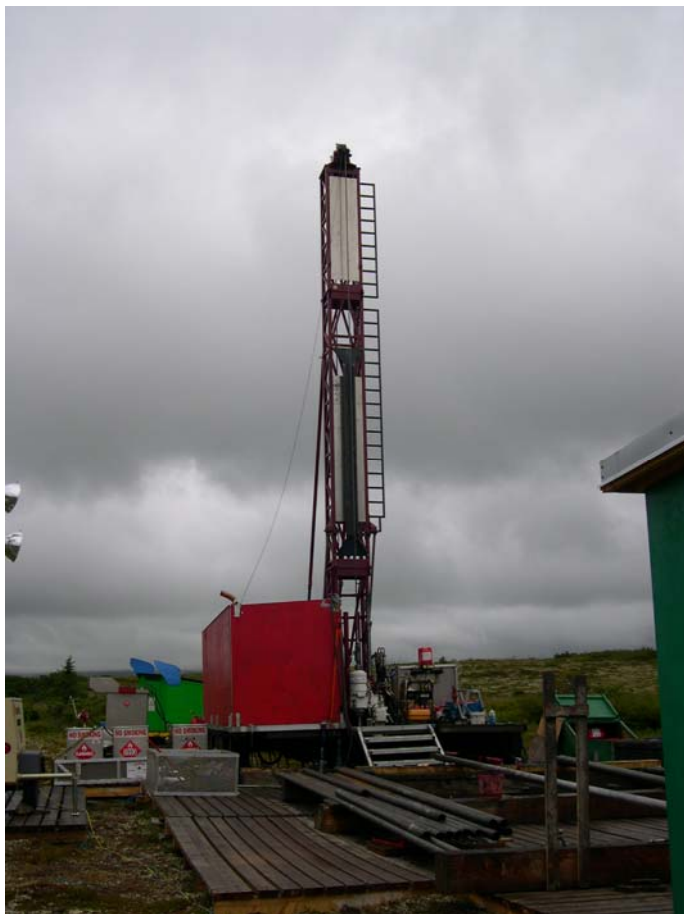
The site visit to the proposed mine area was carried out by helicopter. The first landing site was a drilling rig located due east of Koktuli Ridge on a saddle north of Frying Pan Lake (Figure 1). The drill site was clean and orderly (Figure 2). To minimize impacts to the tundra, drilling structures were placed on mobile wooden platforms constructed of timbers and decking. We observed an area where a drilling platform had been previously, and the impact appeared minimal (Figure 3). One objective of this trip was to inspect water withdrawal approved under Fish Habitat permits 07-II-010, 07-II-011, 07-II-0012, 07-II-013, and 07-II-014. These permits authorize water to be withdrawn from Upper Talarik Creek and designated tributaries for use in drilling operations. Upon arriving in Iliamna, Northern Dynasty staff informed OHMP staff that water was not being withdrawn from the permitted creeks, rather it was being withdrawn from non-fish bearing kettle lakes in the area. Also, water was recycled between drilling rigs to minimize water withdrawal. At each drilling rig, settling sumps (Figure 4) are dug to allow rock flour to settle from the drilling water. There was a centralized settling pond (Figure 5) that received and provided water to several other drilling rigs in the area via a network of pumps and hoses. The kettle pond that served as the primary water source for the visited drilling rig and others in the area exhibited considerable drawdown (Figure 6). To the best of OHMPs knowledge no fish

Figure 2. Visited drilling rig and pad.

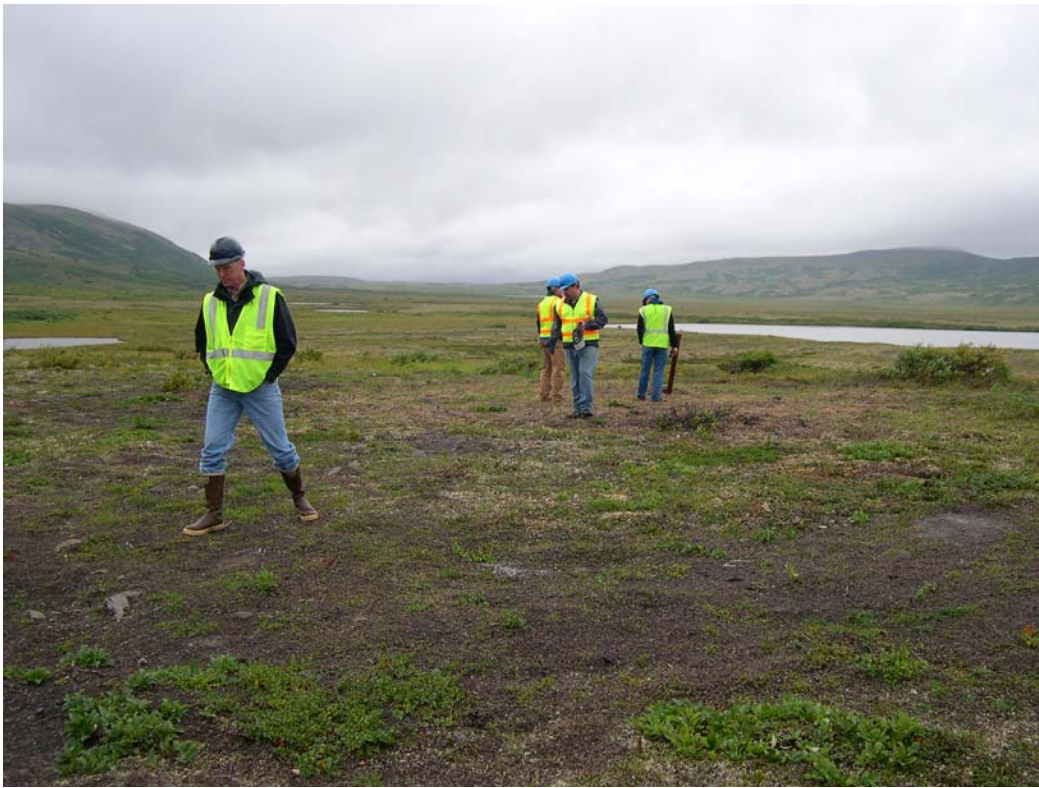
**Figure 3. Location of previous drilling site.**

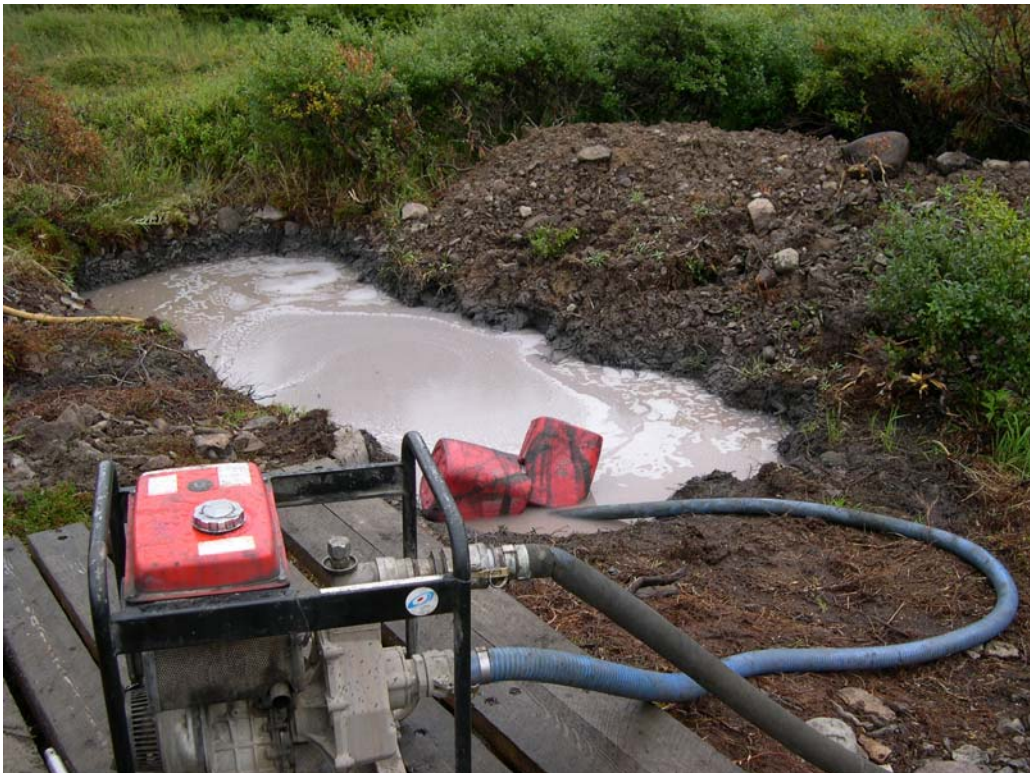
**Figure 4. Settling pond at drill site.**

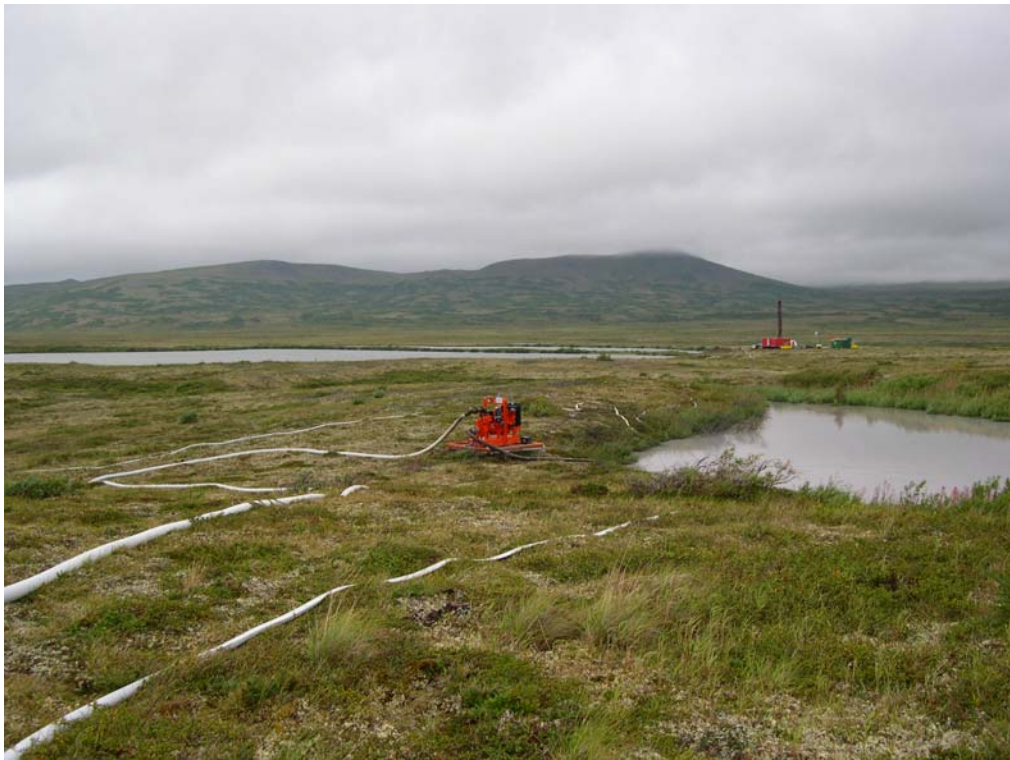
**Figure 5. Centralized settling pond.**

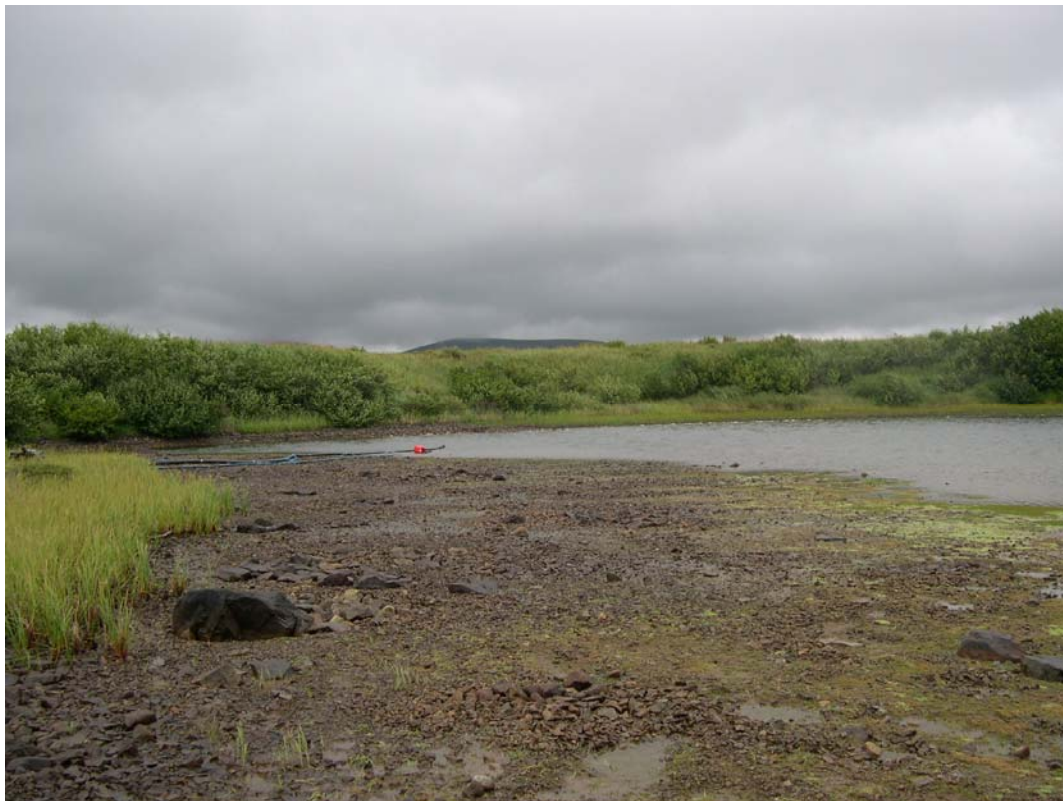
sampling has been conducted in the local kettle lakes and it is assumed they are non-fish bearing. A water intake structure design to prevent fish entrapment and impingement during withdrawal was not visible at this site because the intake hose was submerged. However, we were informed that a structure was in place. I observed another kettle lake that water had previously been withdrawn from, and an intake structure was present. Also noted was extensive helicopter activity (e.g. 3-4 helicopters airborne simultaneously) in the area during the visit. Most of their activity was associated with sling loading equipment.

**Figure 6. Primary water source and observed drawdown.**

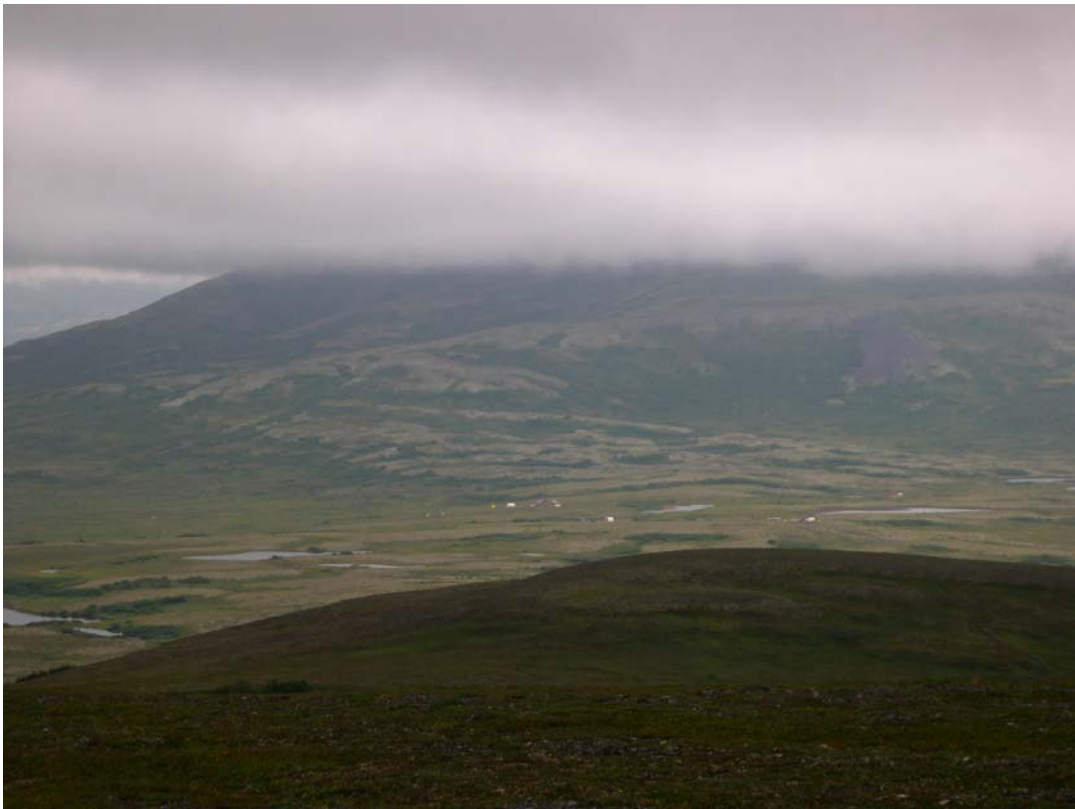
The second landing site was on the eastern side of Koktuli Peak (Figure 1). From this location drill rigs were visible working within the project area and the location provided a good overview of the current exploratory drilling area (Figure 7). The flight back to Iliamna proceeded over the north and south forks of Koktuli River, Big Wiggly Lake, Upper Talarik Creek, and the tentative road access route. I observed several kettle lakes unaffected by drilling operations with low water level were observed throughout the area (Figure 8). A brief tour of the core shack concluded the site visit.

**Figure 7. View of drilling area, looking east from Koktuli Ridge.**

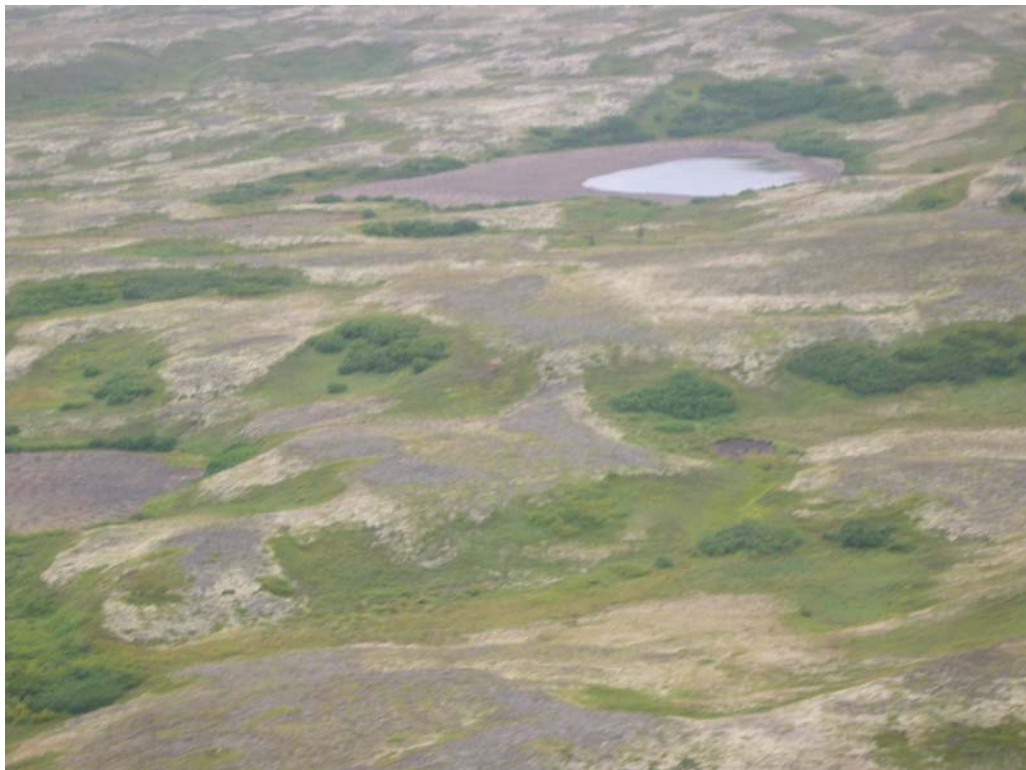
**Figure 8. Typical observed kettle lake unaffected by exploratory drilling showing low water level.**
