Field Report -Pebble Copper/Gold Exploration Project-

Personnel: Patricia Bettis (ADNR/MLW) and
Jeff Estensen (ADNR/OHMP)

Site Visit Date: September 6, 2007

APMA No.: A076118

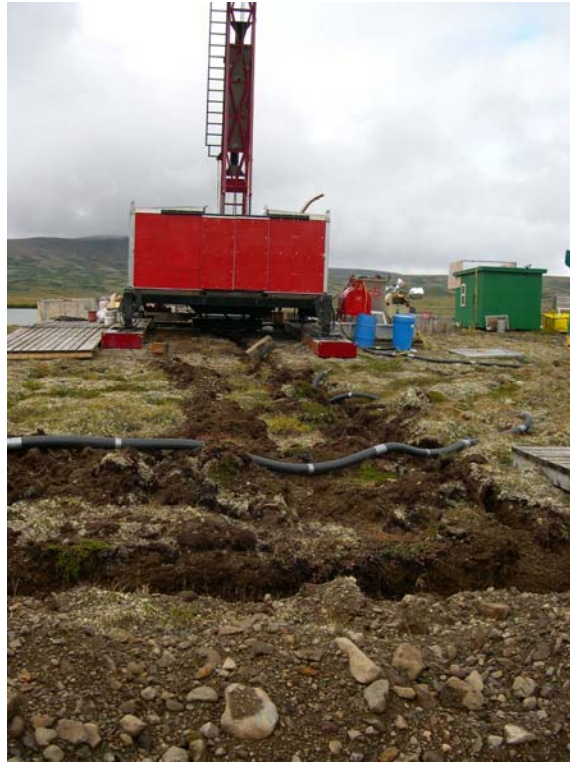
- Location: **Next to rig.**
- Discharge trench: **Yes. Approx 6 inches deep and 10 inches wide, measured 54 ft from platform to sump pit (Figure 1).**
- Dimension pit: **Max 6 feet in depth, 2 to 5 feet in width.**
- In use: **No.**

Figure 1. Rig no. 5 on new site. Trench leads from rig to sump pit.

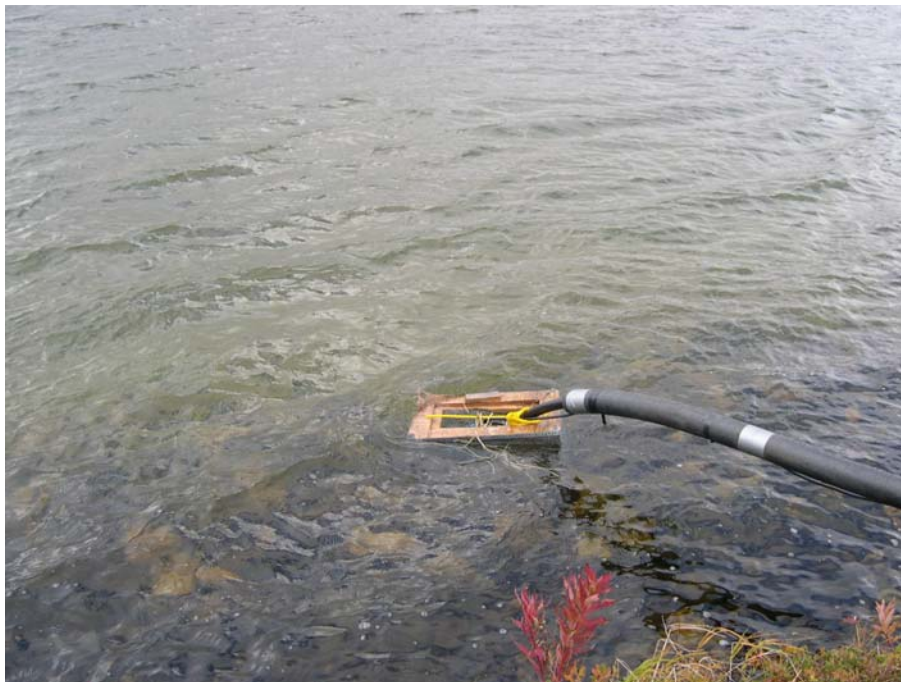
- Intake structure: **In use. Intake cover box missing, (Figure 4). However, it was quickly covered when staff was made privy of it.**
 - Structure clear of debris: **Yes.**

Figure 4. Water intake structure for drill site no. 7374 and for rig no. 5 new drill site.
Note cover missing on intake box.

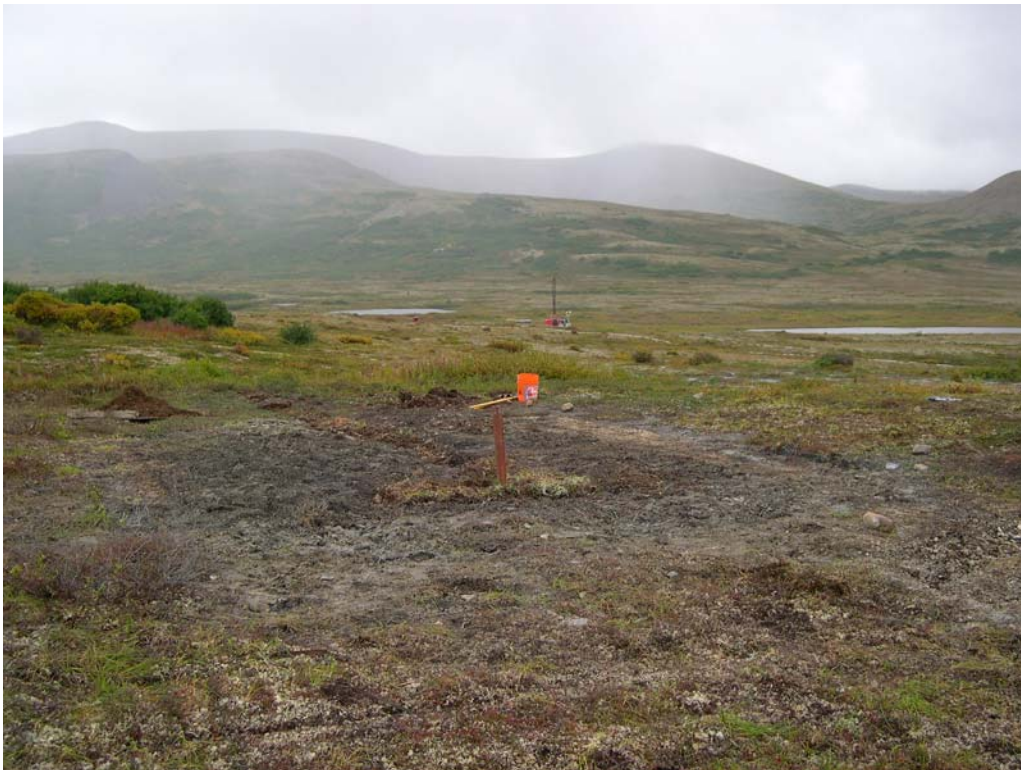
- Plugged: **Yes.**
- Cemented: **Unknown.**
- Standing pipe: **No. Wooden stake marked the location.**
- Sump pit filled in: **Not used. Drilling water discharge was on tundra (prior to change in operation that required sump pit use).**
- Water discharge trench filled in: **Yes.**
- Site re-vegetated: **No.**
- Artesian water present: **No.**
- Any spills or staining, or 'none': **None observed.**
- Comments: **Reclaimed site (RCS) 7368 had a more visible footprint with bare soil observed, (Figure 6). However, there was indication of reclamation work in progress.**

Figure 6. Reclamation site 7368.
