Field Report -Pebble Copper/Gold Exploration Project-

Site Visit Date: 13 September 2007

APMA No.: A076118

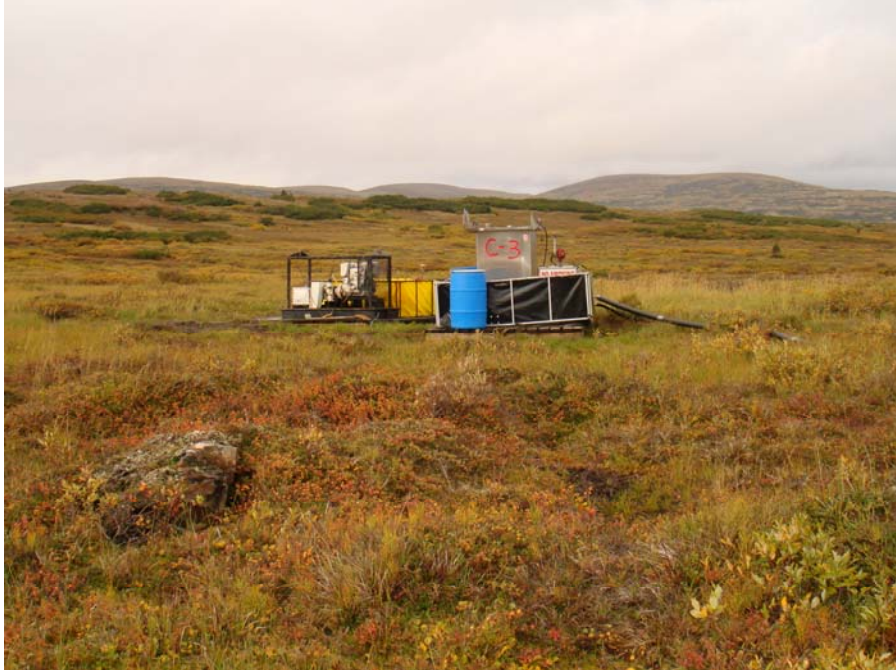
- Stream/Lake/Pond: **Well**
- Location: **N59 53 52.2 W155 15 09.2 (NAD27AK)**
- Adequate water flow and depth for fish passage in streams? **NA**
- Evidence of significant impacts to riparian vegetation or stream banks? **NA**
- Relative water level? **NA**
- General impression of water body, i.e. clear, turbid, tannic colored, etc.? **NA**
- Intake structure: **NA**
- Structure clear of debris: **NA**
- Mesh size: **NA**
- Submerged: **NA**
- Pump location to source: **NA**
- Catch basin for fuel supply: **Yes**
- Sorbent Pads Present or Not: **Yes**
- Hose color: **Yellow**

Figure 2. Water supply for Drill Rig 7, well "EZE-H5330".

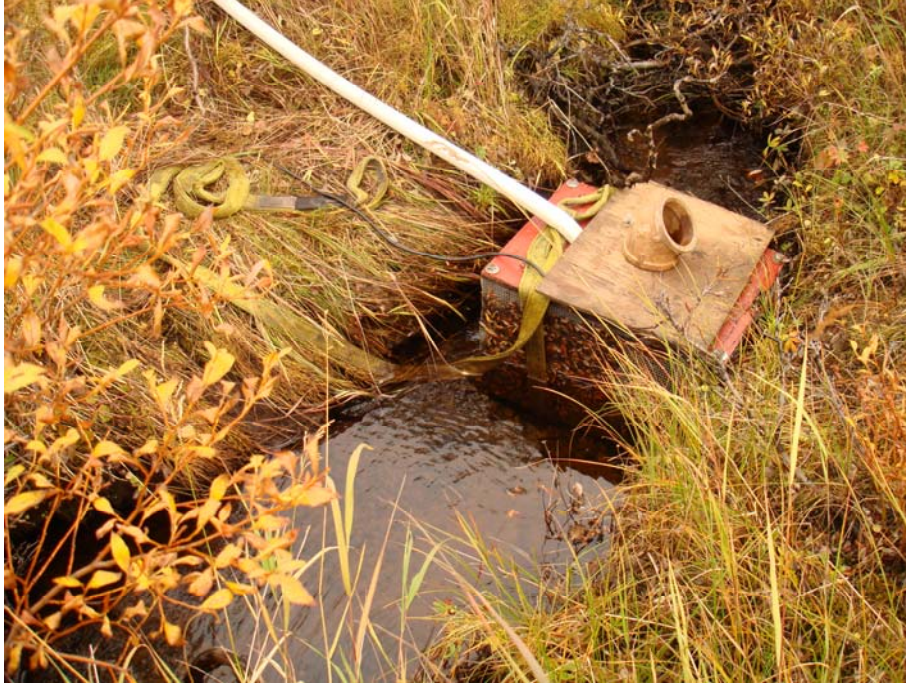
- Stream/Lake/Pond: **Surface water**
- Location: **N59 53 57.7 W155 15 03.9 (NAD27AK)**
- Adequate water flow and depth for fish passage in streams? **NA**
- Evidence of significant impacts to riparian vegetation or stream banks? **No impact to stream bank observed.**
- Relative water level? **Came up halfway on intake screen box.**
- General impression of water body, i.e. clear, turbid, tannic colored, etc.? **Good. Clear waters observed. No indication of pollution or sedimentation.**
- Intake structure: **In use. Intake cover box in place.**
- Structure clear of debris: **Yes, some leaves on screen above water.**
- Mesh size: **0.25 inches**
- Submerged: **Yes, as deep as it could go.**
- Pump location to source: **Approx. 100 feet.**
- Catch basin for fuel supply: **Yes.**
- Sorbent Pads Present or Not: **Yes.**
- Hose color: **White**

Figure 3. Water intake screen at water source for Drill Rig 1.

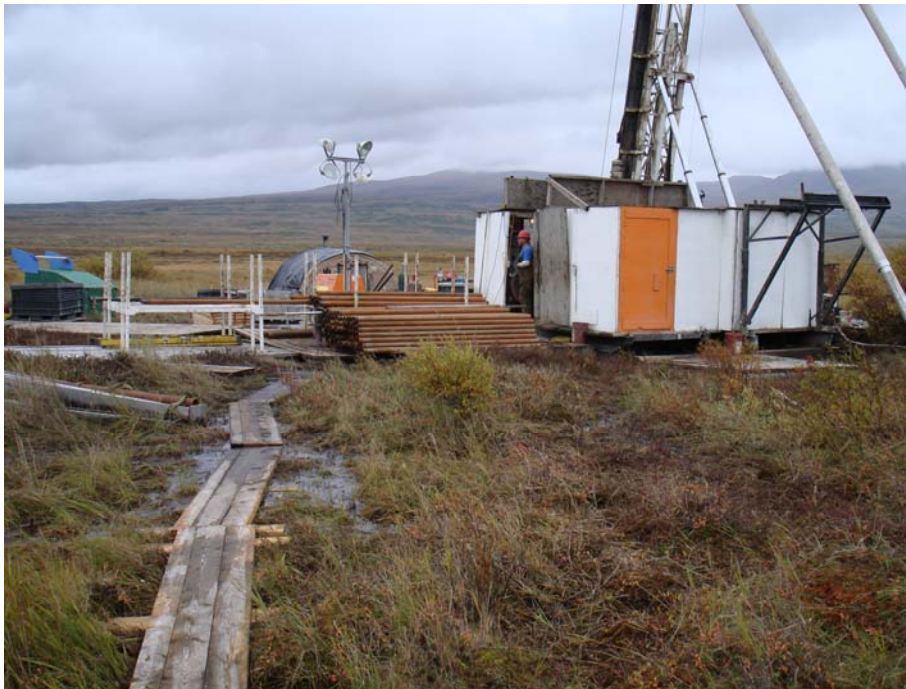
- Distance from water body: ~100'
- Location of fuel storage: **On pad.**
- Sorbent Pads Present or Not: **Yes**
- Tundra Mat: **Yes**
- Pipe off Tundra: **Mostly, 2 sticks of pipe on tundra. Others stockpiled on platform.**
- Litter: **Some minor personal litter (cups, empty food wrappers)**
- Trash Containment: **Yes**
- Sanitary Facilities: **Yes**
- Any spills or staining, or 'none' for that matter: **None**
- General impression of site: **Not as clean and tidy as Rig No. 7, however no serious environmental concerns.**

Figure 4. Drill Rig 1.

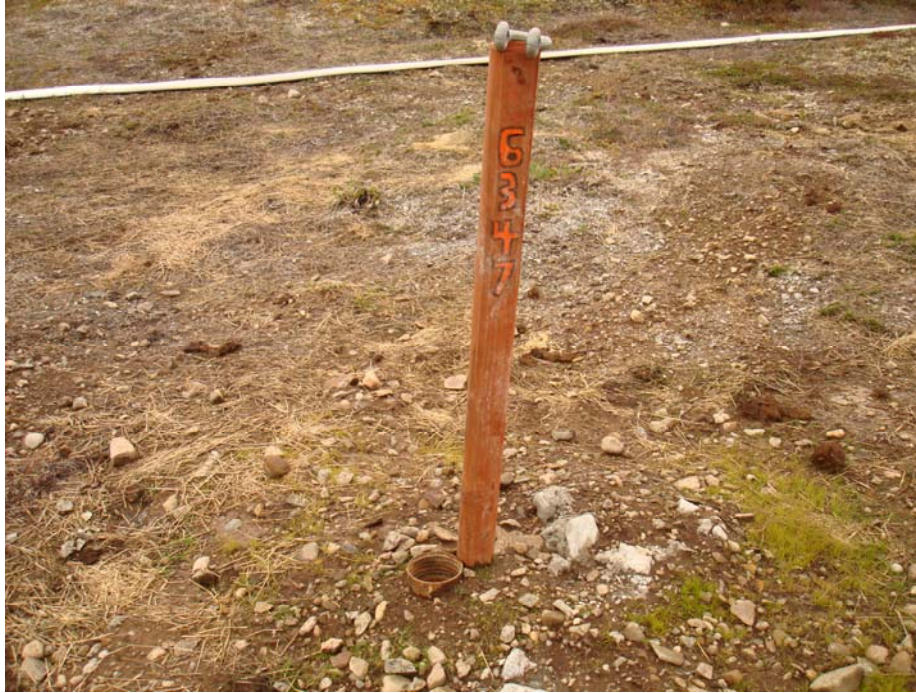
- Plugged: **No.**
- Cemented: **No.**
- Standing pipe: **Yes, and wooden stake marked location site.**
- Sump filled in: **NA.**
- Water discharge trench filled in: **Yes.**
- Site re-vegetated: **No.**
- Artesian water present: **No.**
- Any spills or staining, or 'none': **None observed.**
- Comments: **Drill hole is not plugged or cemented yet and site has apparently not been reclaimed although there is straw/hay onsite indicative of seeding activities. Looking down the borehole a glare is apparent 10'-20' downhole. No trenches, pits or sumps seen. It appears as if this site utilized the centralized cuttings pond adjacent to site for discharge via a surface expression.**

Figure 5. Ground surface near borehole 6347.

- Drillholes not in use anymore should be plugged appropriately and drill sites reclaimed. One hole was located that was drilled in 2006 and not plugged or reclaimed (drill hole 6347).

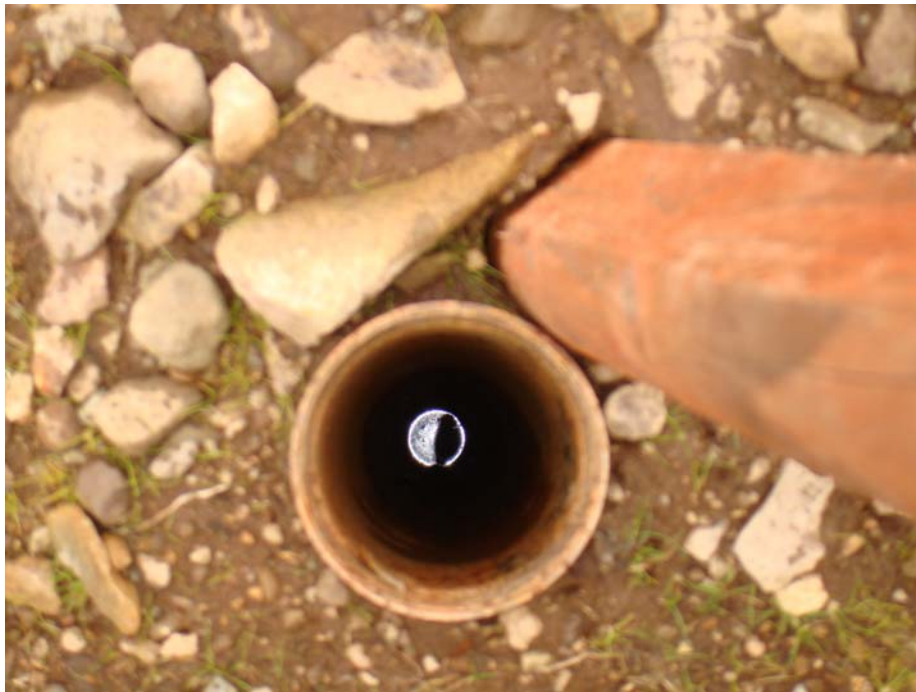
Figure 6. View down borehole 6347.
