# STATE OF ALASKA

## DEPARTMENT OF NATURAL RESOURCES

## Pebble Project Inspection

**Date:** September 26-27, 2007

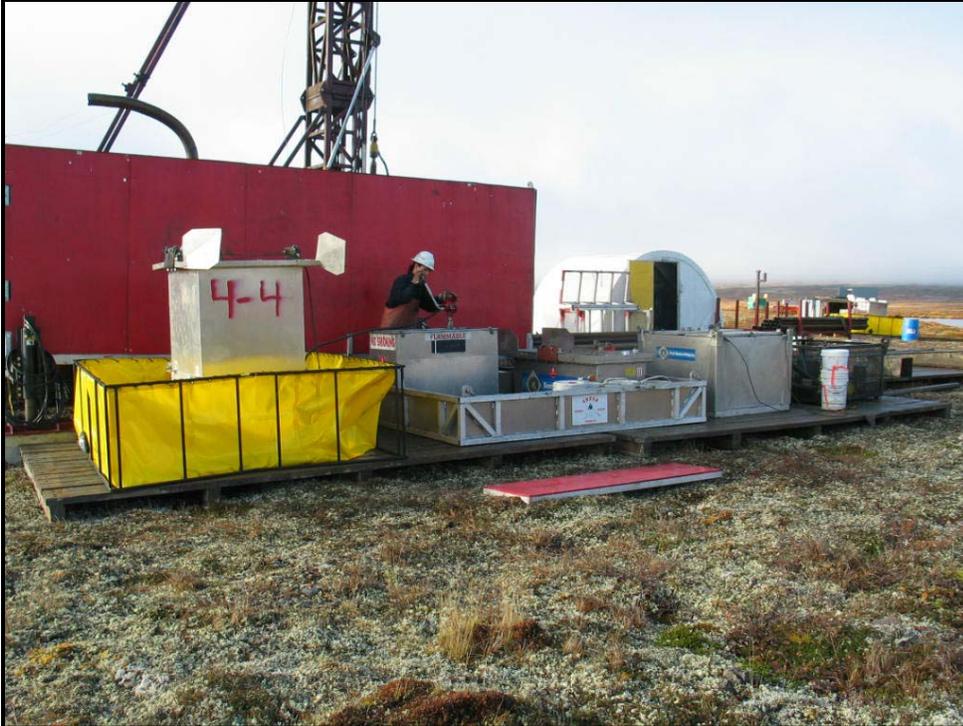
- General appearance - does the rig look to be in good order? Are there any obvious problems, like a spill of a petroleum product?
- Fuel storage - Is all fuel stored in proper primary and secondary containment structures? There are generally several fuel containers, including one for the crew shack. Diesel fuel for the drill rigs is helicopter slung into an aluminum container in 118 gallon, double walled aluminum tanks, then pumped into a larger adjacent tank. The larger tank is situated within a heavy plastic liner for secondary containment. The metal containers are used to prevent tears in the plastic during slinging operations. (See photos #1 and 2.)

Photo #1. A drill crewmember pumps fuel from 118 gallon aluminum slinging tank into main fuel storage tank at drill #4. Note that the sling tank is in a metal containment. The main fuel tank is in the yellow plastic containment.

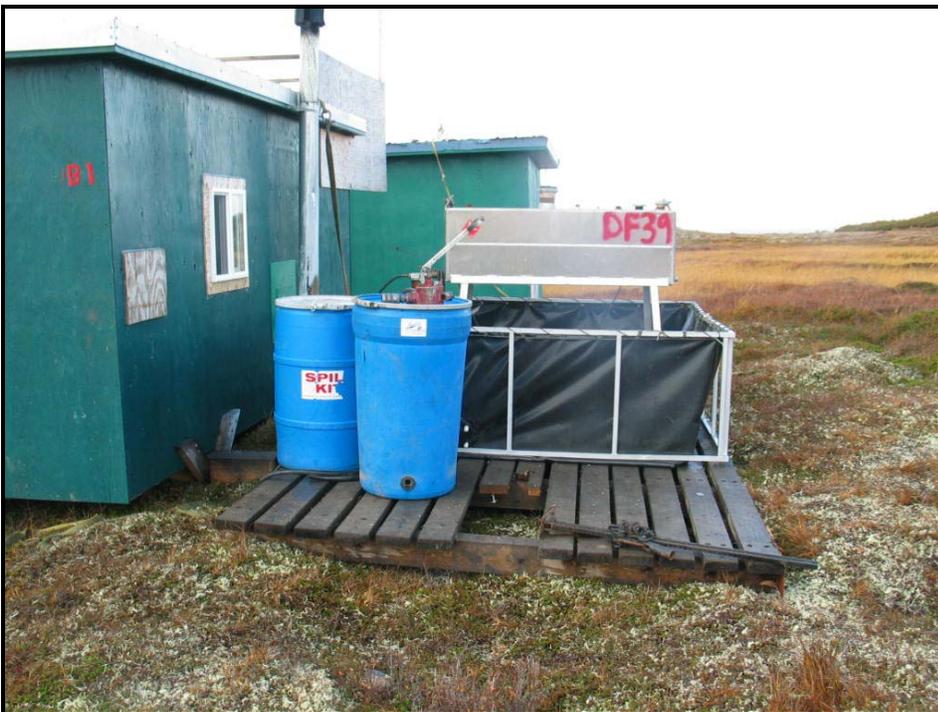
Photo #2. Fuel tank and containment for crew quarters on drill site.

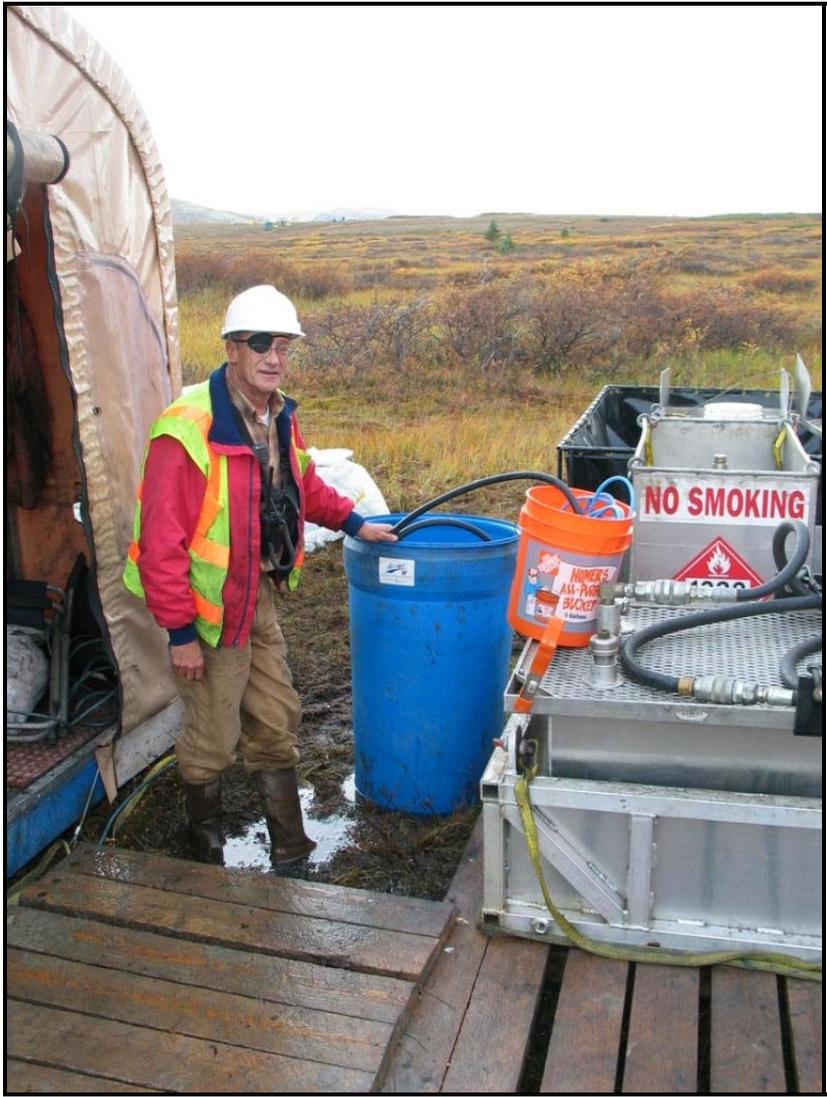
- Each rig should have both a spill kit and a scrubber barrel. If the water pump is any distance from the rig, it should have these items as well. (See photos #3 and 4.)

Photo #3. Gary Martello processing water from a containment berm through a scrubber barrel to remove any petroleum products. All containment berms are cleaned by this process as needed after rains.

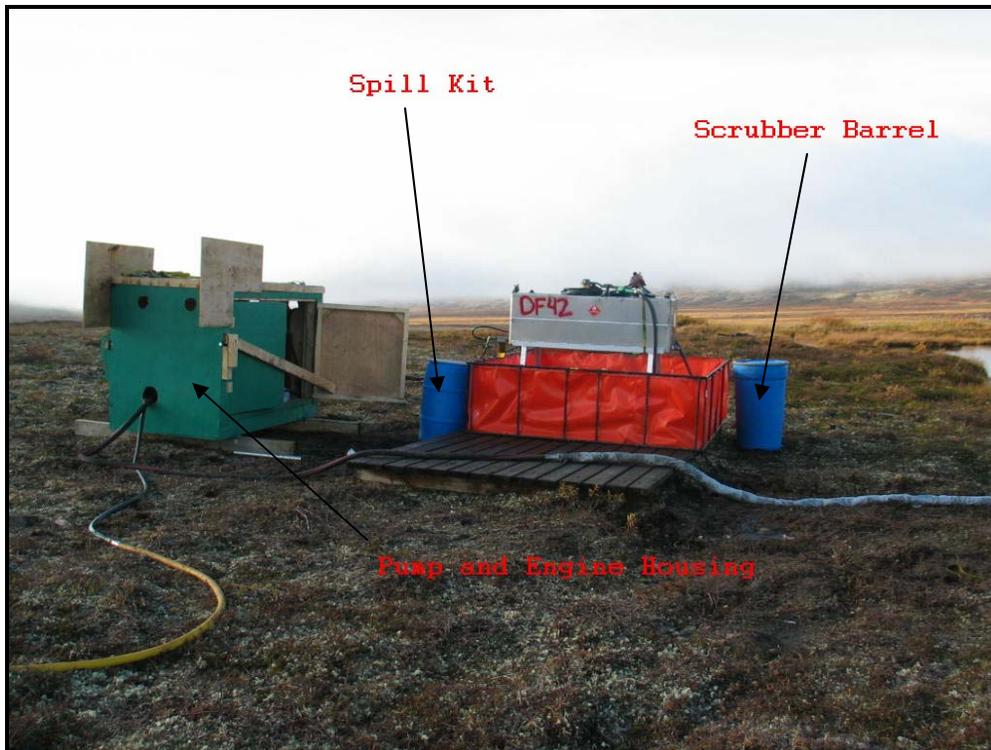
Photo #4. Spill kit and Scrubber barrel at water intake for pump #4. Note that engine and pump are kept in a wooden containment held off the tundra by timbers.

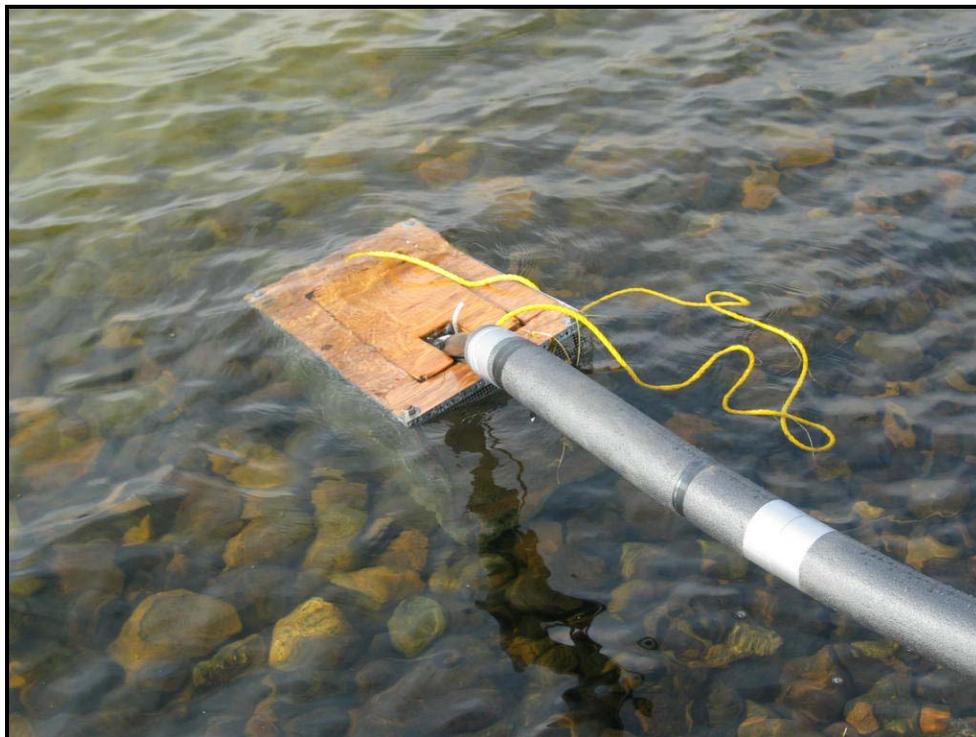
Drill #5 was the only rig taking water from a possible fish bearing lake during our inspection. There were three intake lines in the lake, including a submersible electric pump. All three intakes were seen to have fish screens. (See photo #5.)

Photo #5. Fish screen on water intake at drill #5.

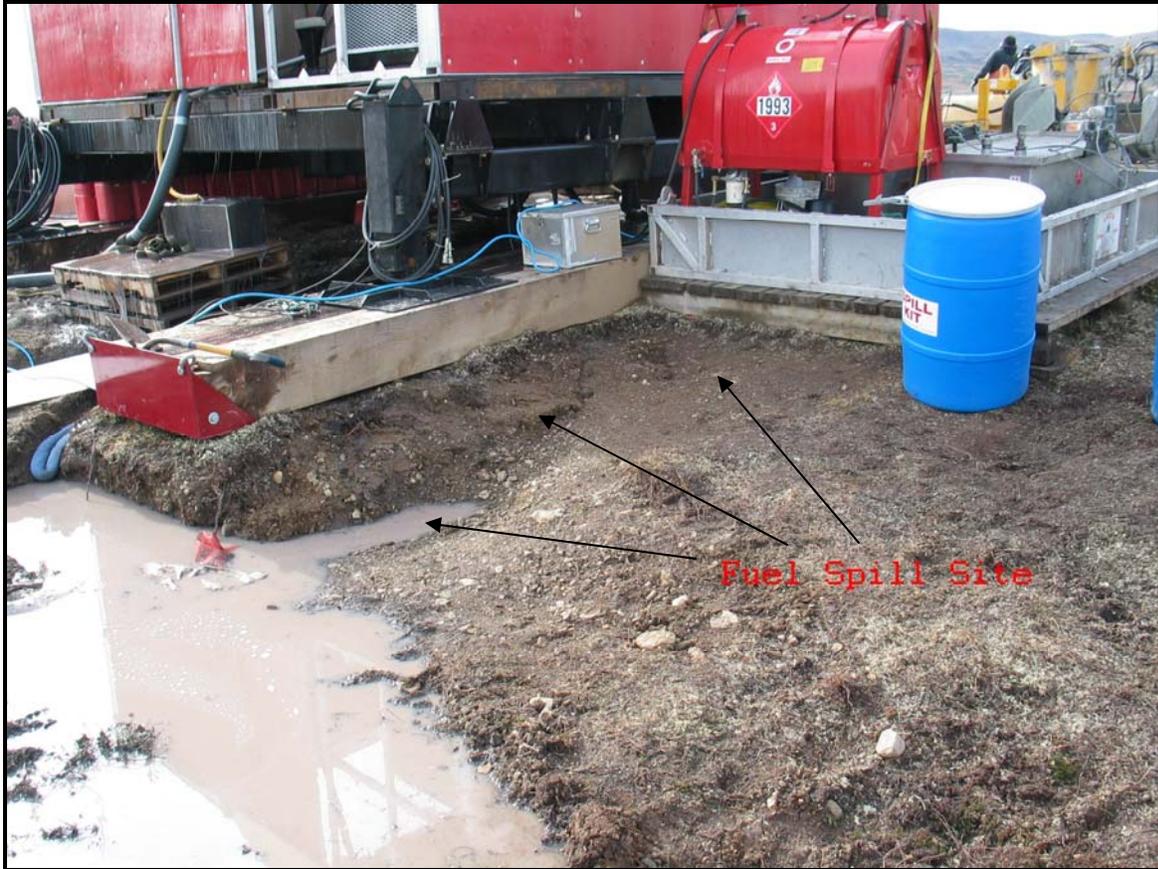
On September 10, 2007 Northern Dynasty had a 12 gallon diesel spill at drill #5. The spill was excavated and removed to a disposal site in Oregon. Photo #6 shows the cleaned up spill site. Separate reports of the spill and clean up have been submitted to both the Department of Natural Resources and the Department of Environmental Conservation.

Photo #6. Site of September 10, 2007 fuel spill at drill #5.

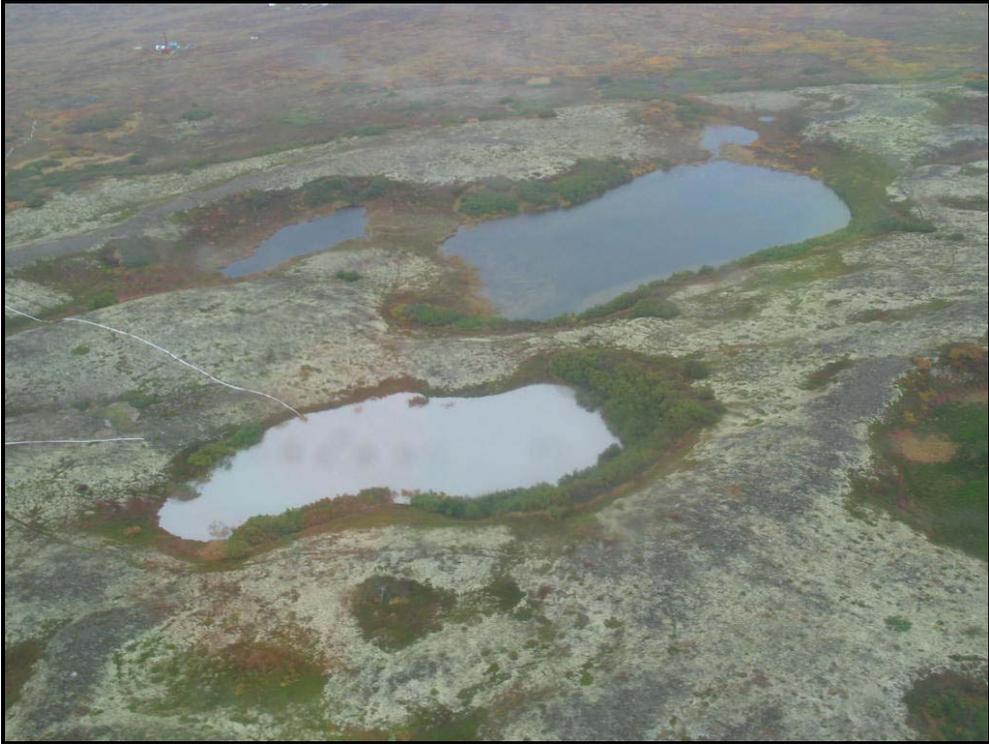
Fluids from most drill holes are being pumped to previously dry depressions on high ground for disposal. At the time of our visit, two such depressions were in use. Small ponds adjacent to the discharge sites remain clear, indicating that either the drilling fluids are not flowing toward these nearby ponds or that the ground is effectively filtering the discharge waters before they reach the ponds. (See photos #7-9.) During our inspection drill #3 was being discharged over a small rise onto the Tundra. We flew over the discharge site on the afternoon of the 27<sup>th</sup>, and the discharge was being absorbed into the tundra well before reaching any wetlands. (See photo #10.)

Photo #7. The larger o two disposal sites and adjacent ponds.

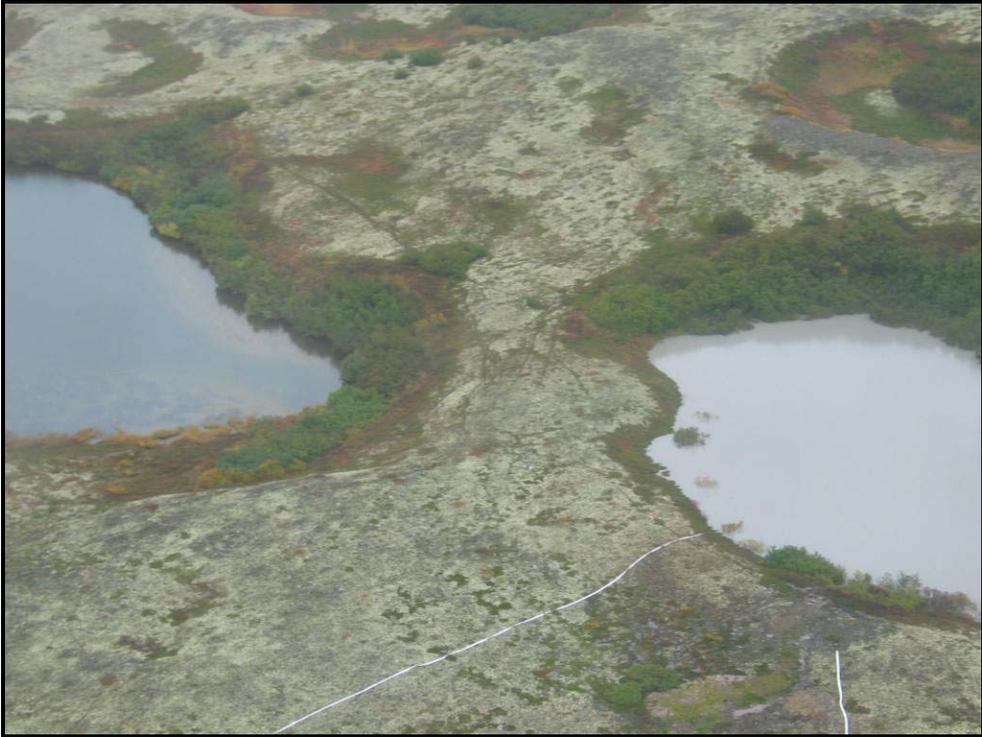
Photo #8. Disposal site and adjacent pond.

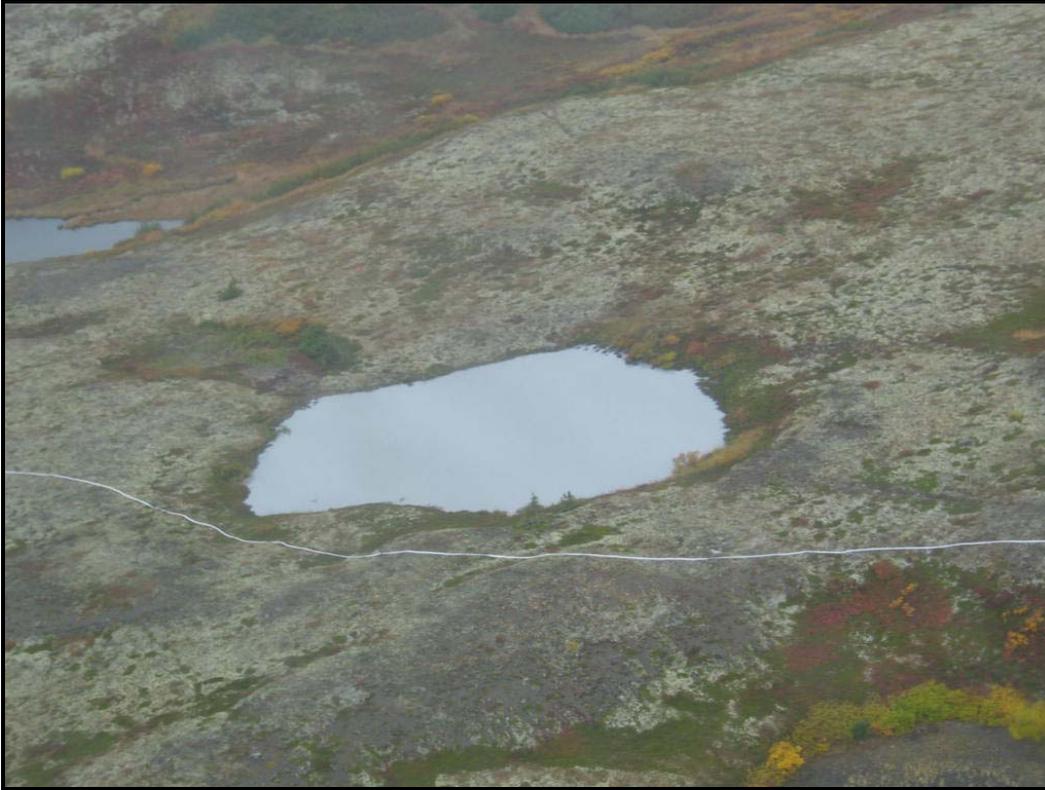
Photo #9. Smaller of two disposal sites.

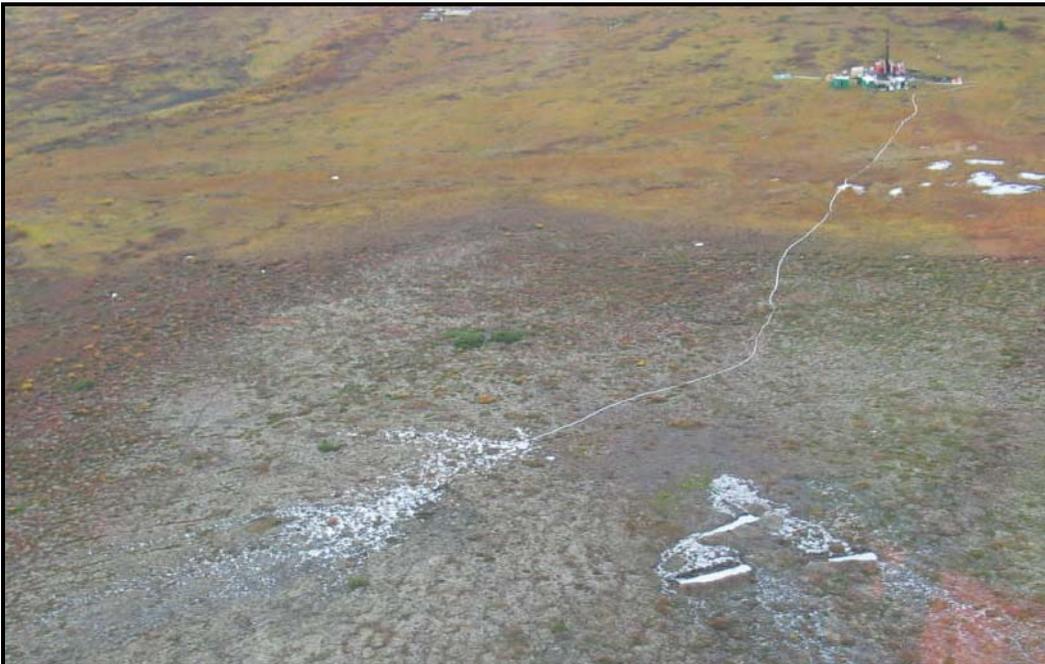
Photo #10. Drill #3 and drilling discharge. An unreclaimed drill site is in the foreground.

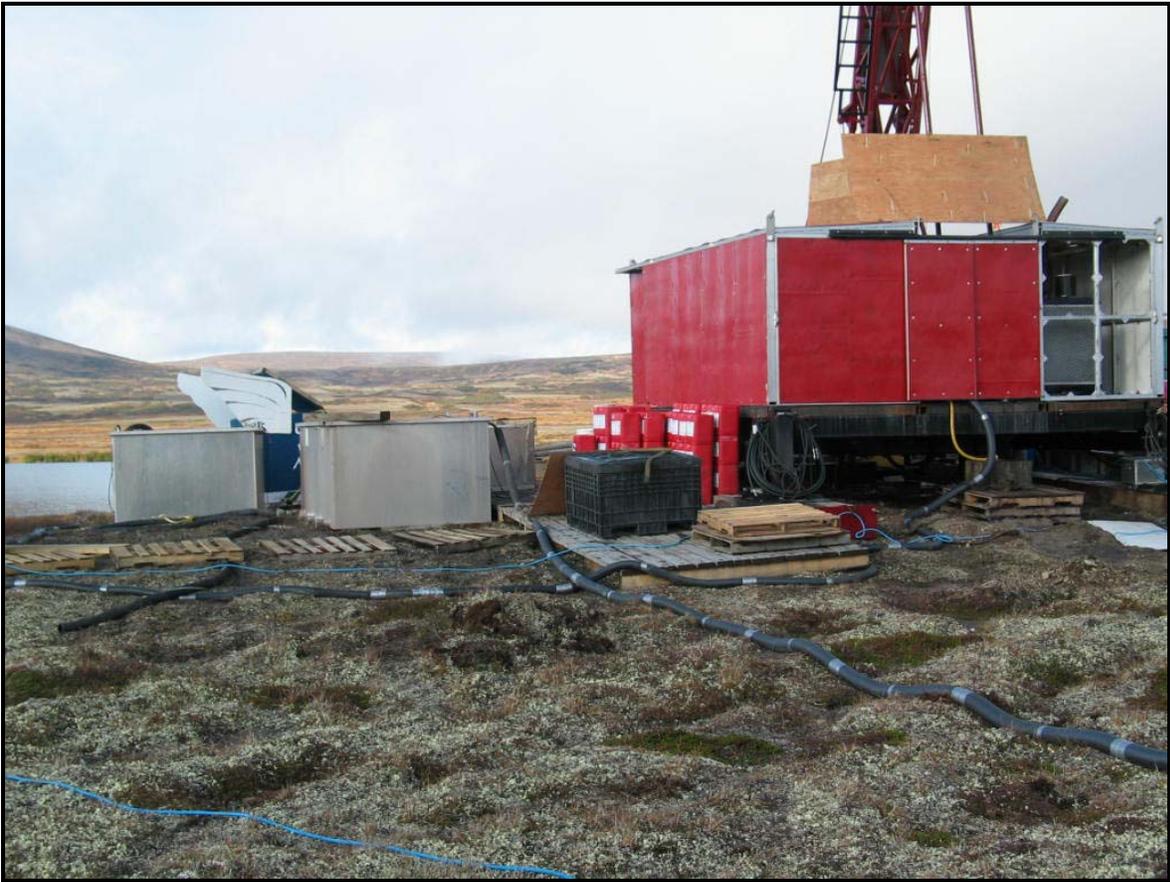
A few drills are recirculating their return fluids. (See photos #11 and 12.) Recirculation requires a larger sump, and one or two large tanks for mixing the mud. Recirculating the returns saves a considerable amount of discharge, but not all, because most wells make some amount of down hole water. The excess water must be disposed of. (See Drill Inspections, above.)

Photo #11. Extra tanks required for recirculating drilling fluids at drill #1.

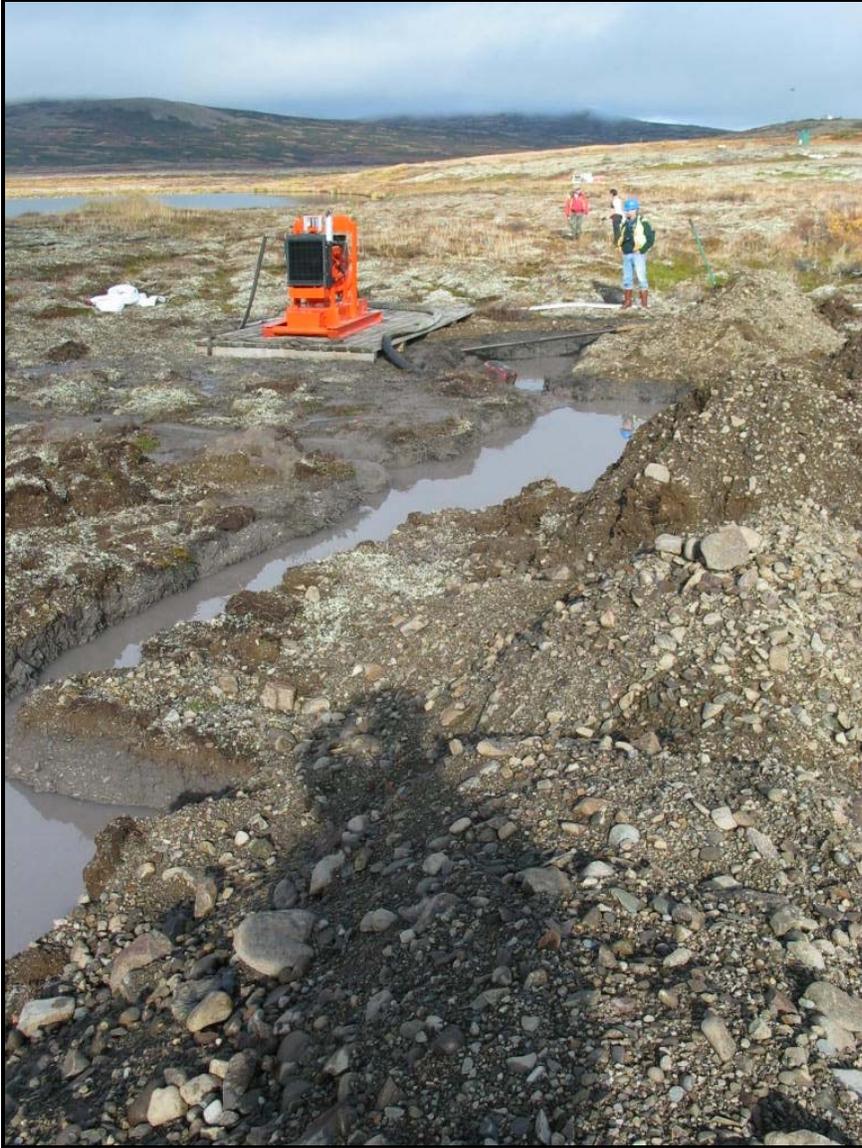
Photo #12. Larger sump required for recirculating fluids at drill #5.

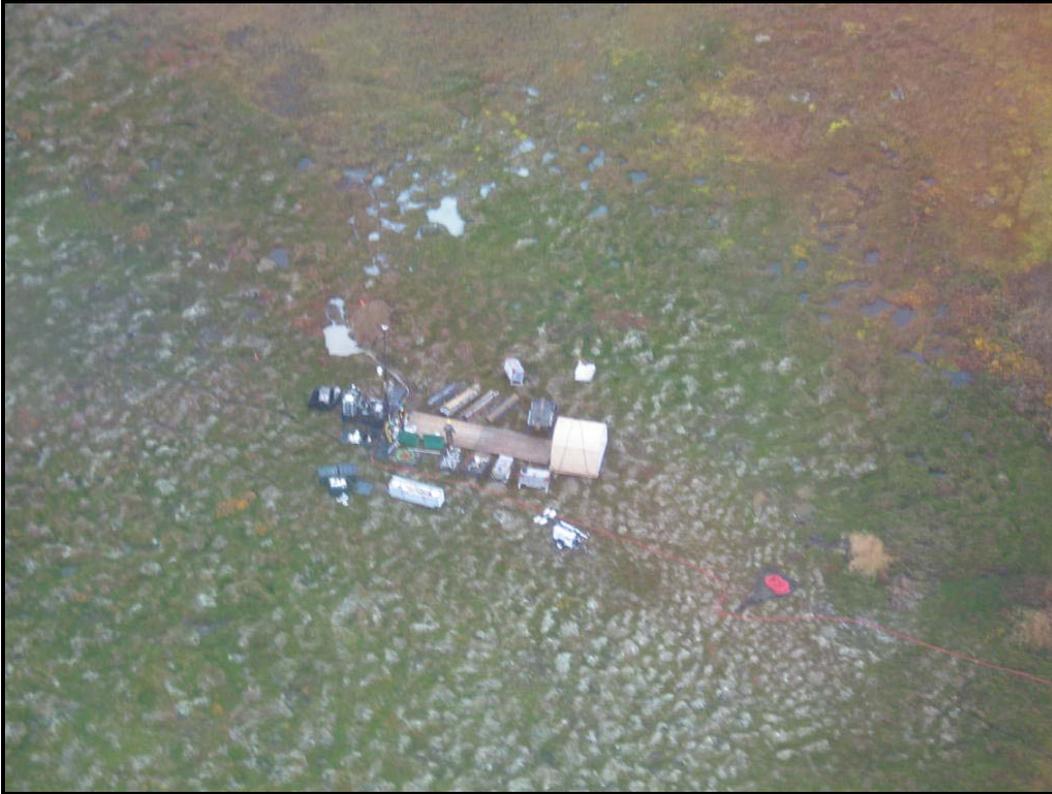
Northern Dynasty is investigating a long, north-south valley about four miles west of the deposit as a possible tailings disposal site. They are drilling a number of geotechnical holes in the valley, primarily to determine the depth to bedrock and type of sediments in the overburden. We flew over the valley, but did not land. We saw a number of abandoned geotechnical holes, and one active drill. Everything seemed to be in good order. (See photo #13.)

Photo #13. Geotechnical drill in potential tailings disposal area. Approximately section 14, T3S, R36W SM.

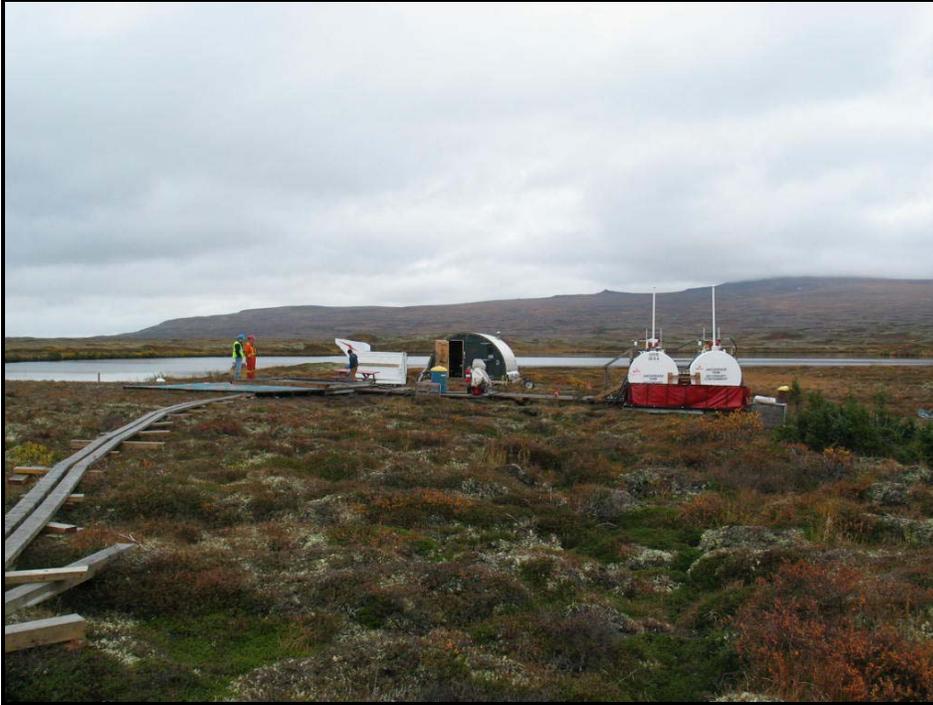
On the afternoon of the 26<sup>th</sup> we inspected the main fuel storage at Big Wiggley Lake, in section 5, T3S, R35E SM. Everything was in good order. (See July 26-27, 2007 report for more details on the facilities at Big Wiggley. See photos #13 and 14.) We noted that there are now three spill containment float booms, and there is an electric motor on the dock to pump fuel from the Beaver to the main tanks. This eliminates the need for fuel and an engine along the lake shore. (See photo #15.)

Photo #13. Big Wiggley fuel storage facility – 2,000 gallon storage containment. Boardwalk is for tundra protection.

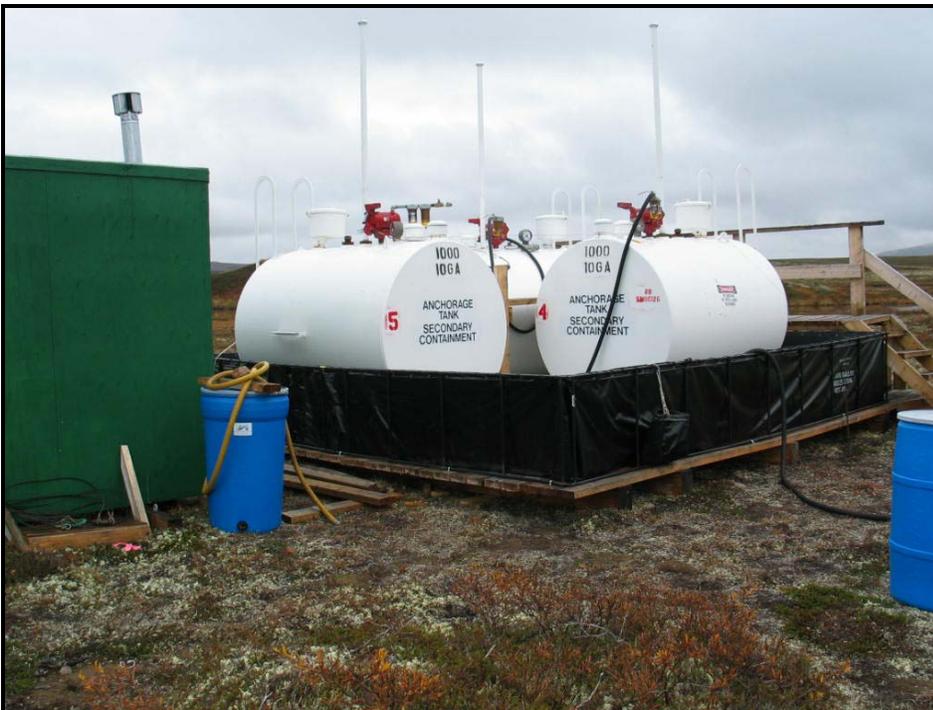
Photo #14. Larger, 3,000 gallon fuel containment at Big Wiggley. Each containment has a large fire extinguisher, spill kit, and scrubber barrel. The facility also has a large container of spill materials.

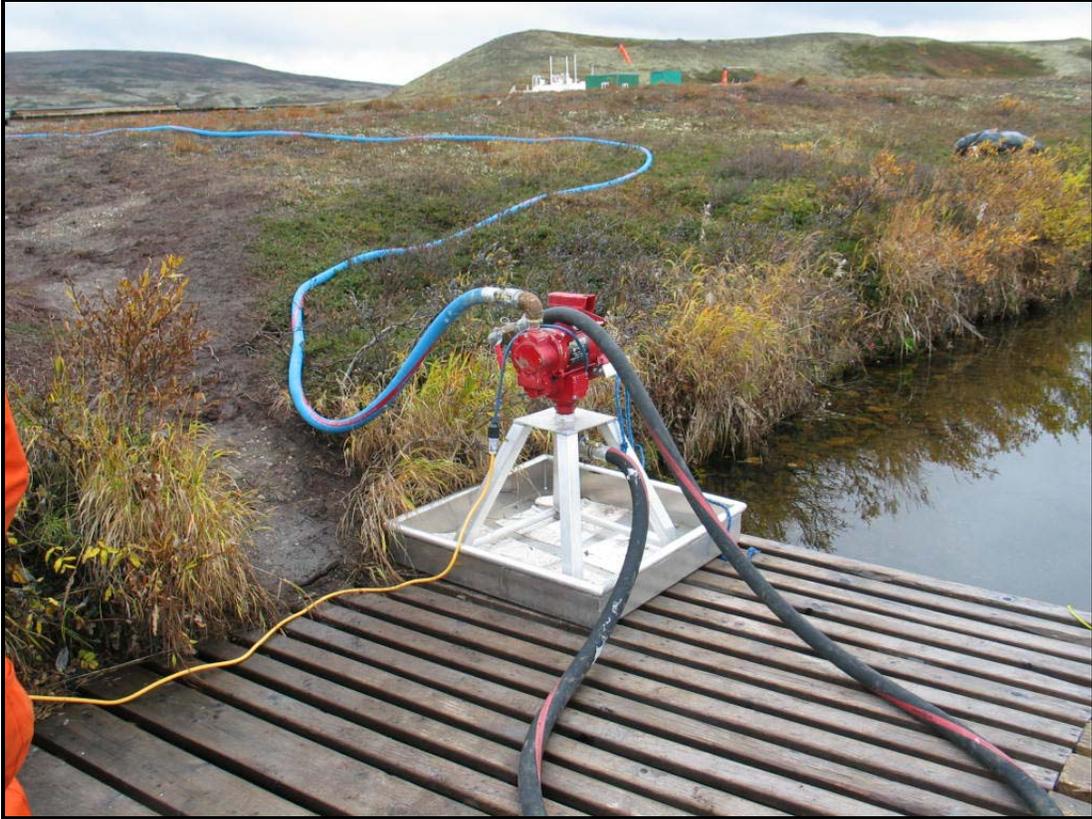
Photo #15. Electric pump on dock at Big Wiggley fuel storage.

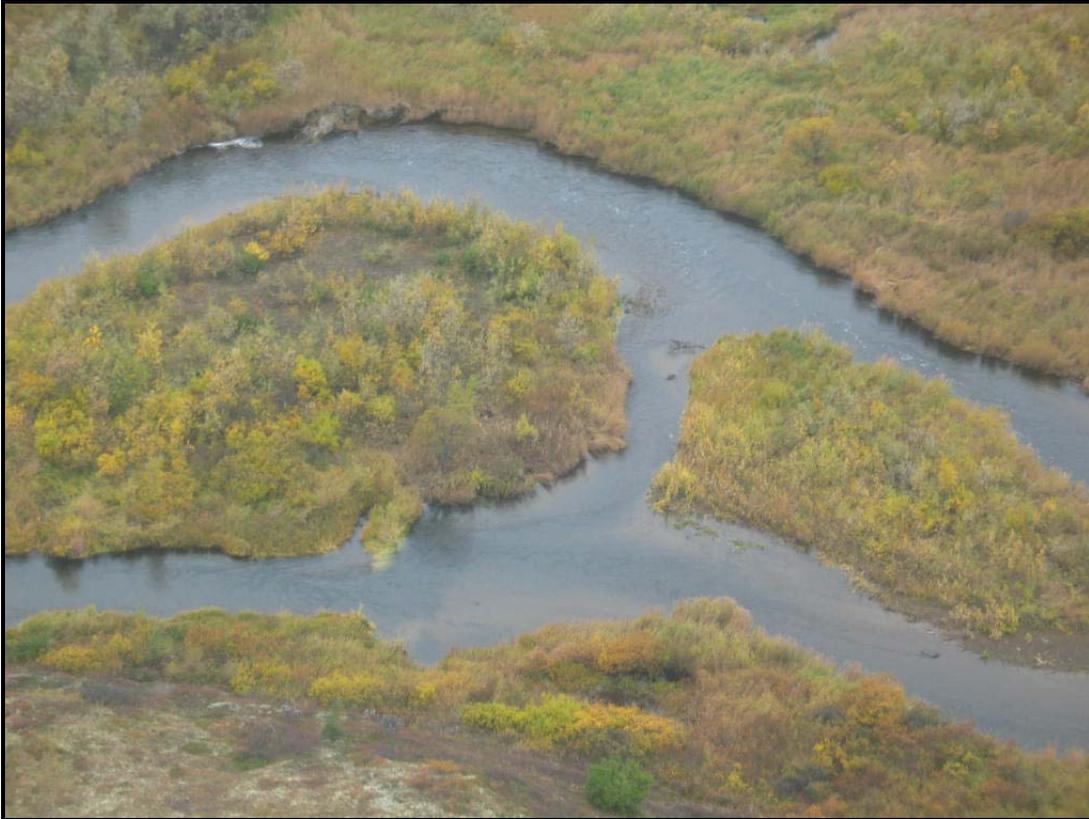
Over the course of our two-day inspection we flew along Upper Talarik Creek through the northern end of the deposit and around the north end of Koktuli Mountain on two occasions. The creek was clear, with no visual indications of contaminants from drilling operations. (See photo #16.)

Photo #16. Upper Talarik Creek, north of Koktuli Mountain.
