# Field Inspection Report

## -Pebble Copper/Gold Exploration Project-

Inspection Date: May 7, 2008

APMA No.: A086118

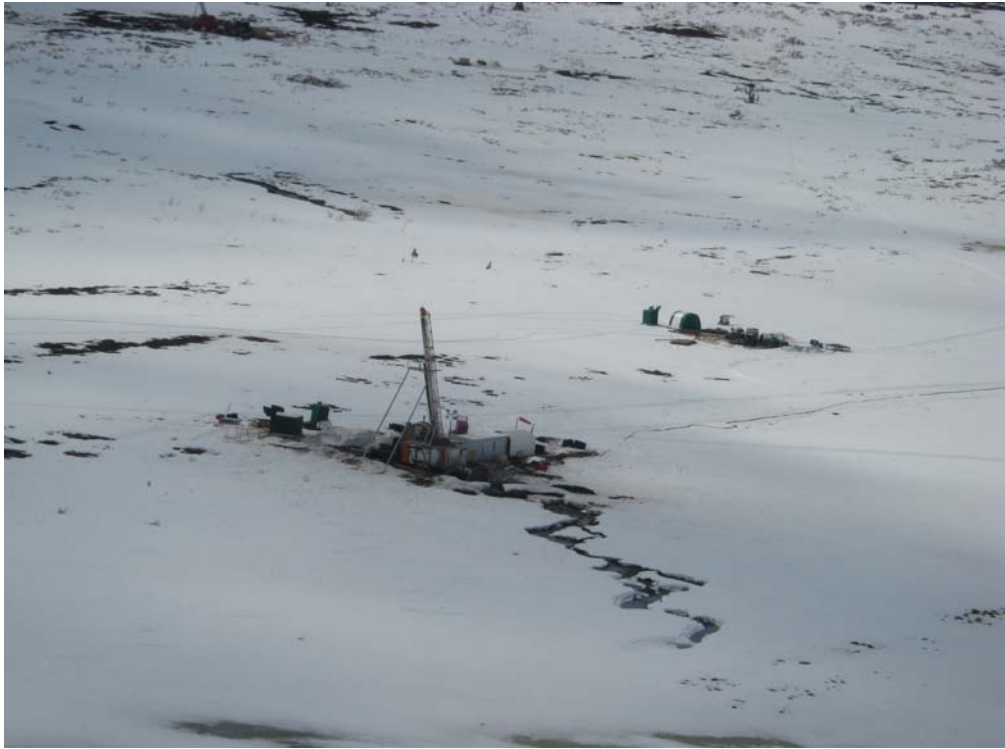
- Distance from water body: **> 600 ft.**
- Location of fuel storage: **On pad**
- Sorbent Pads Present or Not: **Yes**
- Tundra Mat: **Yes**
- Pipe off Tundra: **Yes**
- Litter: **None**
- Trash Containment: **Yes**
- Sanitary Facilities: **Yes**
- Any spills or staining, or 'none' for that matter:  
**None**
- General impression of site: **Clean. No  
disturbance to tundra other than discharged  
slurry of cuttings and drilling muds (Figure 2)**

Figure 2. Drill rig number 2.

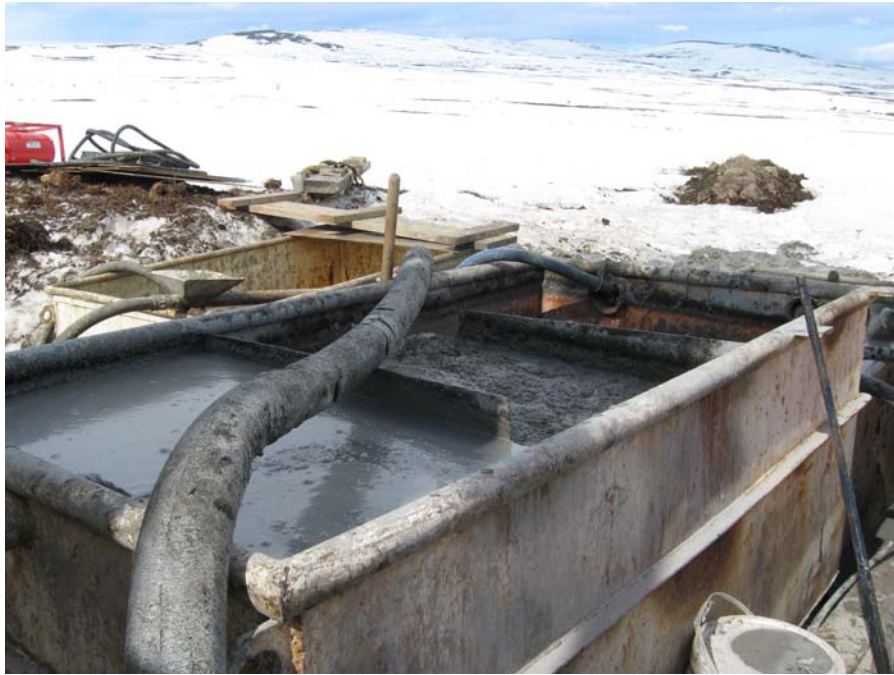
- Drill additives in use (list): **Unknown**
- Drill water discharged: **Onto tundra, settling  
box in use to recycle drilling muds (Figure 3).**
- Water recirculation: **Yes**
- Artesian zone encountered: **Unknown**

Figure 3. Drill rig number 2, settling box for recycling drilling muds.

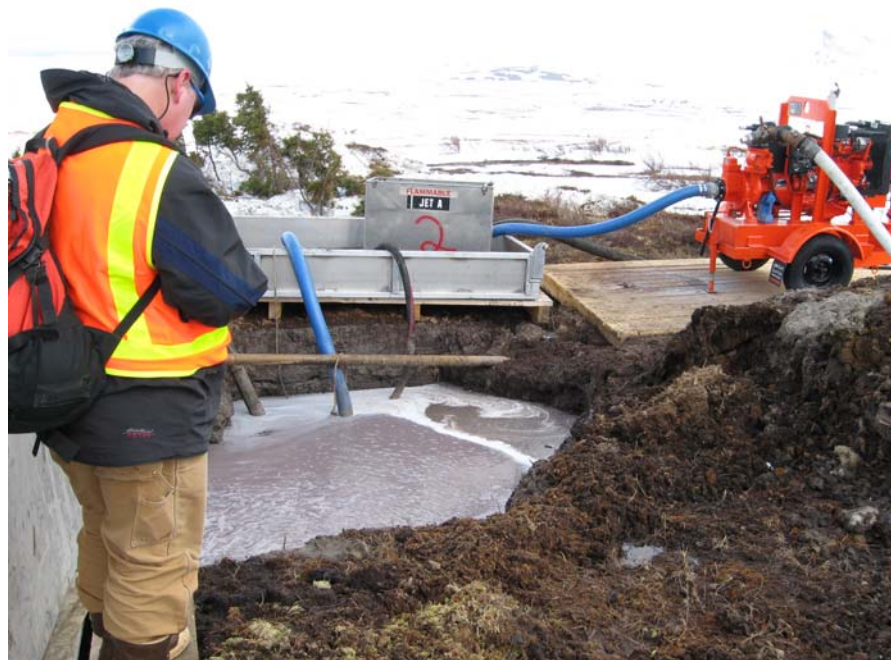
- Distance from water body: **>200 ft.**
- Location of fuel storage: **on pad**
- Sorbent Pads Present or Not: **Yes**
- Tundra Mat: **Yes**
- Pipe off Tundra: **Yes**
- Litter: **No**
- Trash Containment: **Yes**
- Sanitary Facilities: **Y/N**
- Any spills or staining, or 'none' for that matter:  
**None**
- General impression of site: **Clean. No  
disturbance to tundra other than sump pit  
(Figure 5).**

- Location: **adjacent**
- Discharge trench: **No**
- Dimension pit: **~ 8'x 10'**
- In use: **Yes**

- Location and extent of discharged material:  
**> 500' upslope**
- Topsoil, muck, tundra stockpiled: **Yes**
- Location of secondary sump pit: **N/A**
- Hose color: **White**

Figure 5. Drilling water sump, pump, and fuel storage at drill rig number 1. Drilling water was discharged onto uplands over 500 feet away from the drill rig through the white hose.

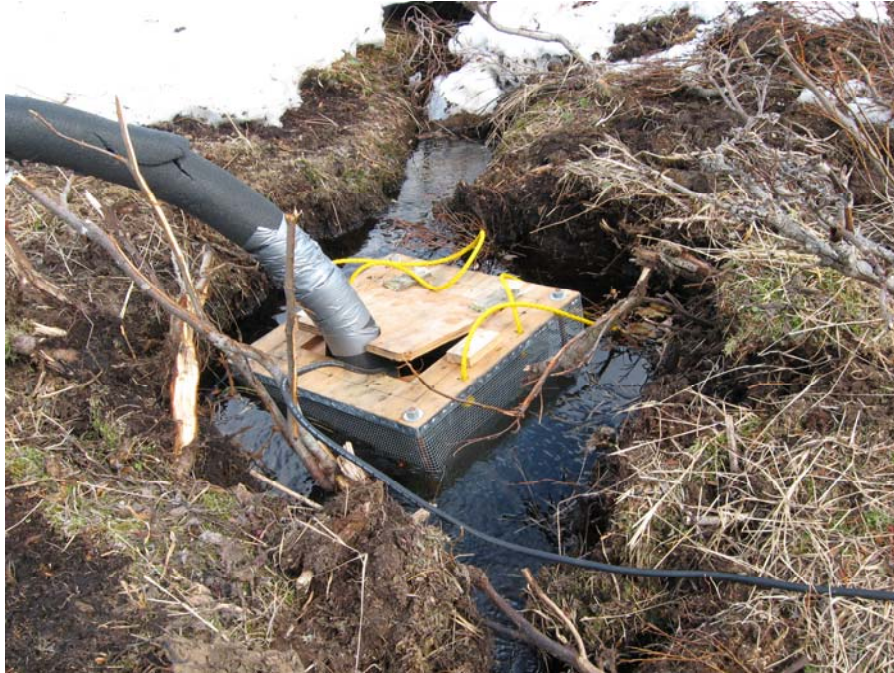
- Stream/Lake/Pond: **Unnamed tributary of  
Upper Talarik Creek (Figure 4)**
- Location: **>200 ft. SW of Rig**
- Adequate water flow and depth for fish passage  
in streams? **N/A**
- Evidence of significant impacts to riparian  
vegetation or stream banks? **None**
- Relative water level? **Base Flow with  
increasing snow melt.**
- General impression of water body, i.e. clear,  
turbid, tannic colored, etc.? **Clear. No  
indication of pollution or sedimentation.**
- Intake structure: **Present**
- Structure clear of debris: **Yes**
- Mesh size: **¼ inch**
- Submerged: **>¾**
- Pump location to source: **> 100 ft**
- Catch basin for fuel supply: **Yes**
- Sorbent Pads Present or Not: **Yes**
- Hose color: **Black (insulated)**

Figure 4. Water withdrawal point, drill rig number 1, Upper Talarik Creek Tributary. Screened intake was placed in an excavated site. Streamflow was observed immediately downstream of the intake in a 6 inch wide channel covered by vegetation.

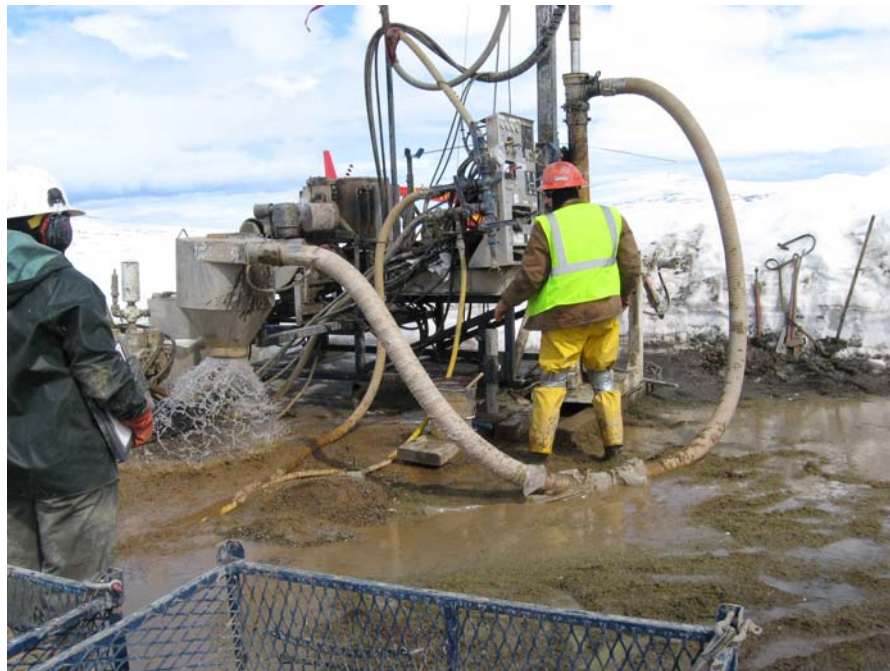
- Distance from water body: **> 200 ft.**
- Location of fuel storage: **On pad.**
- Sorbent Pads Present or Not: **Yes**
- Tundra Mat: **Yes**
- Pipe off Tundra: **Yes**
- Litter: **No**
- Spill Indications: **None**
- Trash Containment: **Yes**
- Sanitary Facilities: **Yes**
- Any spills or staining, or 'none' for that matter:  
**None.**
- General impression of site: **clean, tundra mat  
not in use adjacent to drill (Figure 6).**

Figure 6. Groundwater monitoring well installation, drill rig number 8.

- Search and collect windblown litter.
- Cover trash cans to prevent debris from being blown away.
- Install tundra mat at drill rig number 8 to avoid impacting vegetation.
