## FIELD REPORT --PEBBLE COPPER/GOLD PROJECT--

**Date:** 22 August 2007

**Objectives:** Site visit to Pebble Project, inspect temporary water use for exploratory drilling.

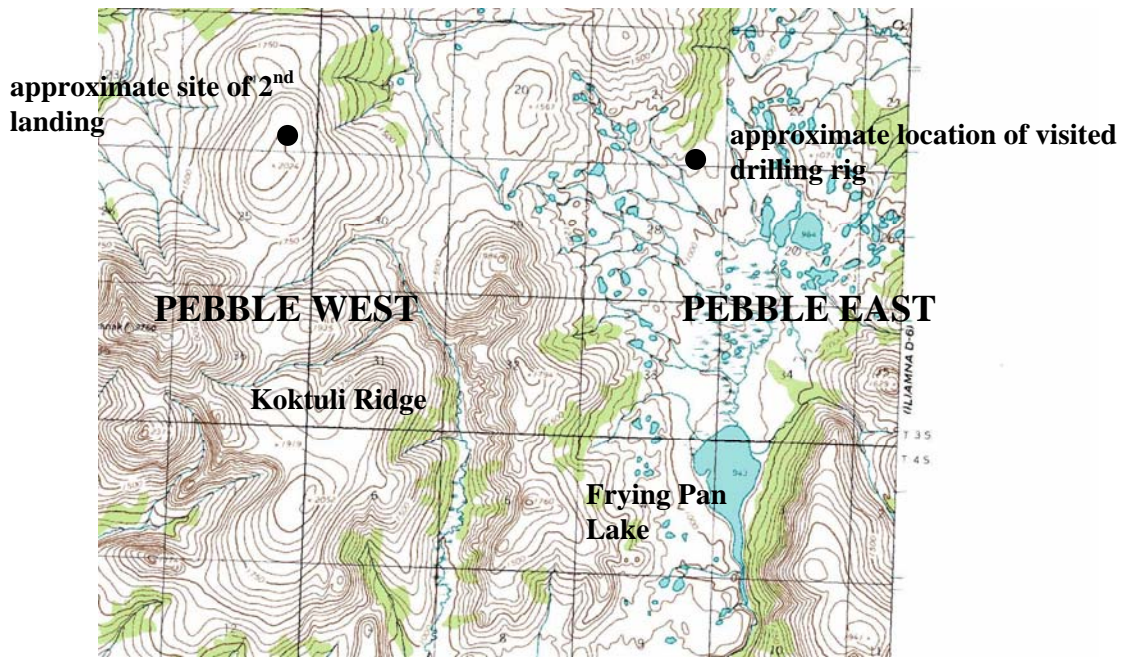
The site visit to the proposed mine area was carried out by helicopter. The first landing site was a drilling rig located due east of Koktuli Ridge on a saddle north of Frying Pan Lake (Figure 1). The drill site was clean and orderly (Figure 2). To minimize impacts to the tundra, drilling structures were placed on mobile wooden platforms constructed of timbers and decking. We observed an area where a drilling platform had been previously, and the impact appeared minimal (Figure 3). One objective of this trip was to inspect water withdrawal approved under Fish Habitat permits 07-II-010, 07-II-011, 07-II-0012, 07-II-013, and 07-II-014. These permits authorize water to be withdrawn from Upper Talarik Creek and designated tributaries for use in drilling operations. Upon arriving in Iliamna, Northern Dynasty staff informed OHMP staff that water was not being withdrawn from the permitted creeks, rather it was being withdrawn from non-fish bearing kettle lakes in the area. Also, water was recycled between drilling rigs to minimize water withdrawal. At each drilling rig, settling sumps (Figure 4) are dug to allow rock flour to settle from the drilling water. There was a centralized settling pond (Figure 5) that received and provided water to several other drilling rigs in the area via a network of pumps and hoses. The kettle pond that served as the primary water source for the visited drilling rig and others in the area exhibited considerable drawdown (Figure 6). To the best of OHMPs knowledge no fish

The second landing site was on the eastern side of Koktuli Peak (Figure 1). From this location drill rigs were visible working within the project area and the location provided a good overview of the current exploratory drilling area (Figure 7). The flight back to Iliamna proceeded over the north and south forks of Koktuli River, Big Wiggly Lake, Upper Talarik Creek, and the tentative road access route. I observed several kettle lakes unaffected by drilling operations with low water level were observed throughout the area (Figure 8). A brief tour of the core shack concluded the site visit.

Figure 1. Landing areas during site visit.
