# Field Inspection Report

## -Pebble Copper/Gold Exploration Project-

Inspection Date: May 7, 2008

APMA No.: A086118

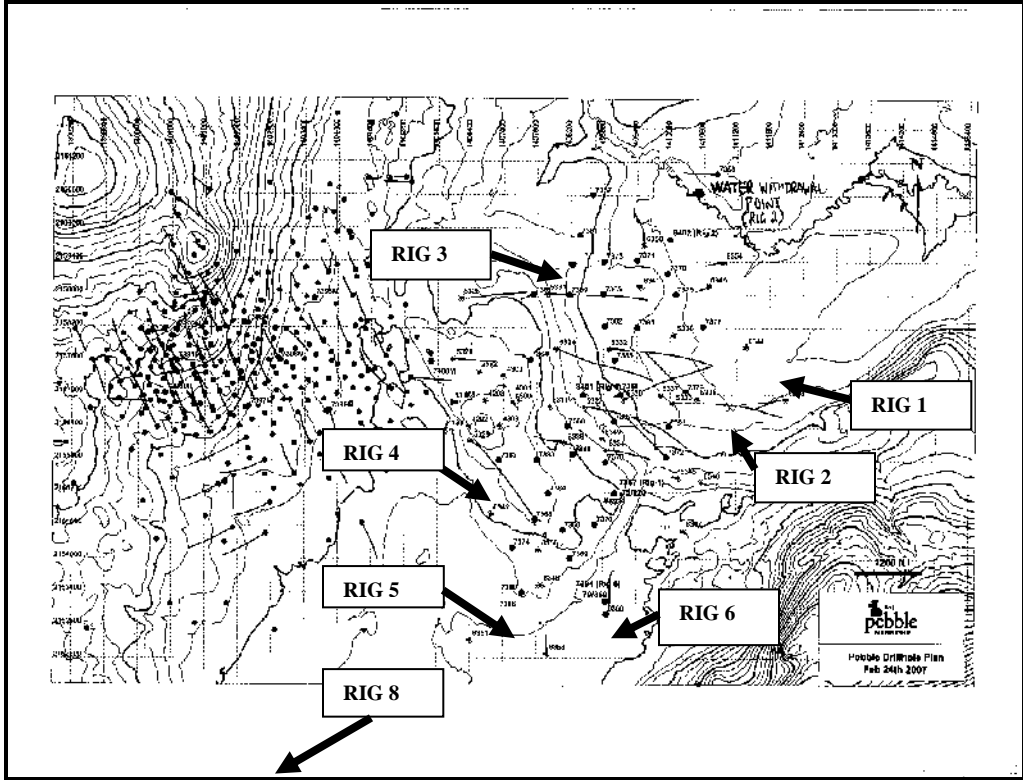
Figure 1. Approximate Location of drilling rigs.

- Complete:  
Partial: **Visited four of the eight drill rigs that were in operation or being installed (Figure 1).**
- Follow-up:
- Response to complaint:
